## Addendum 2

December 10, 2020

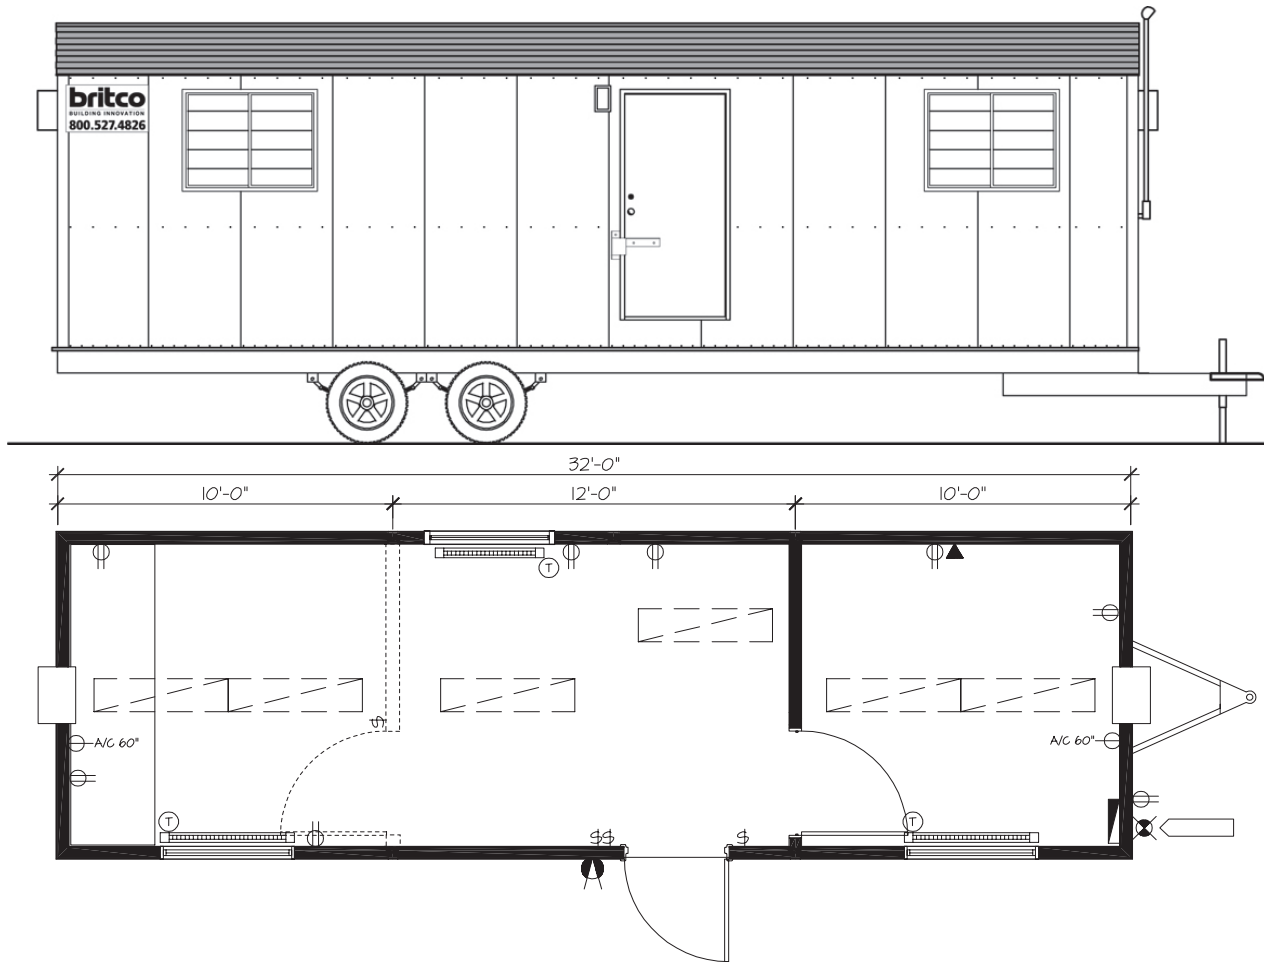
### General Specifications

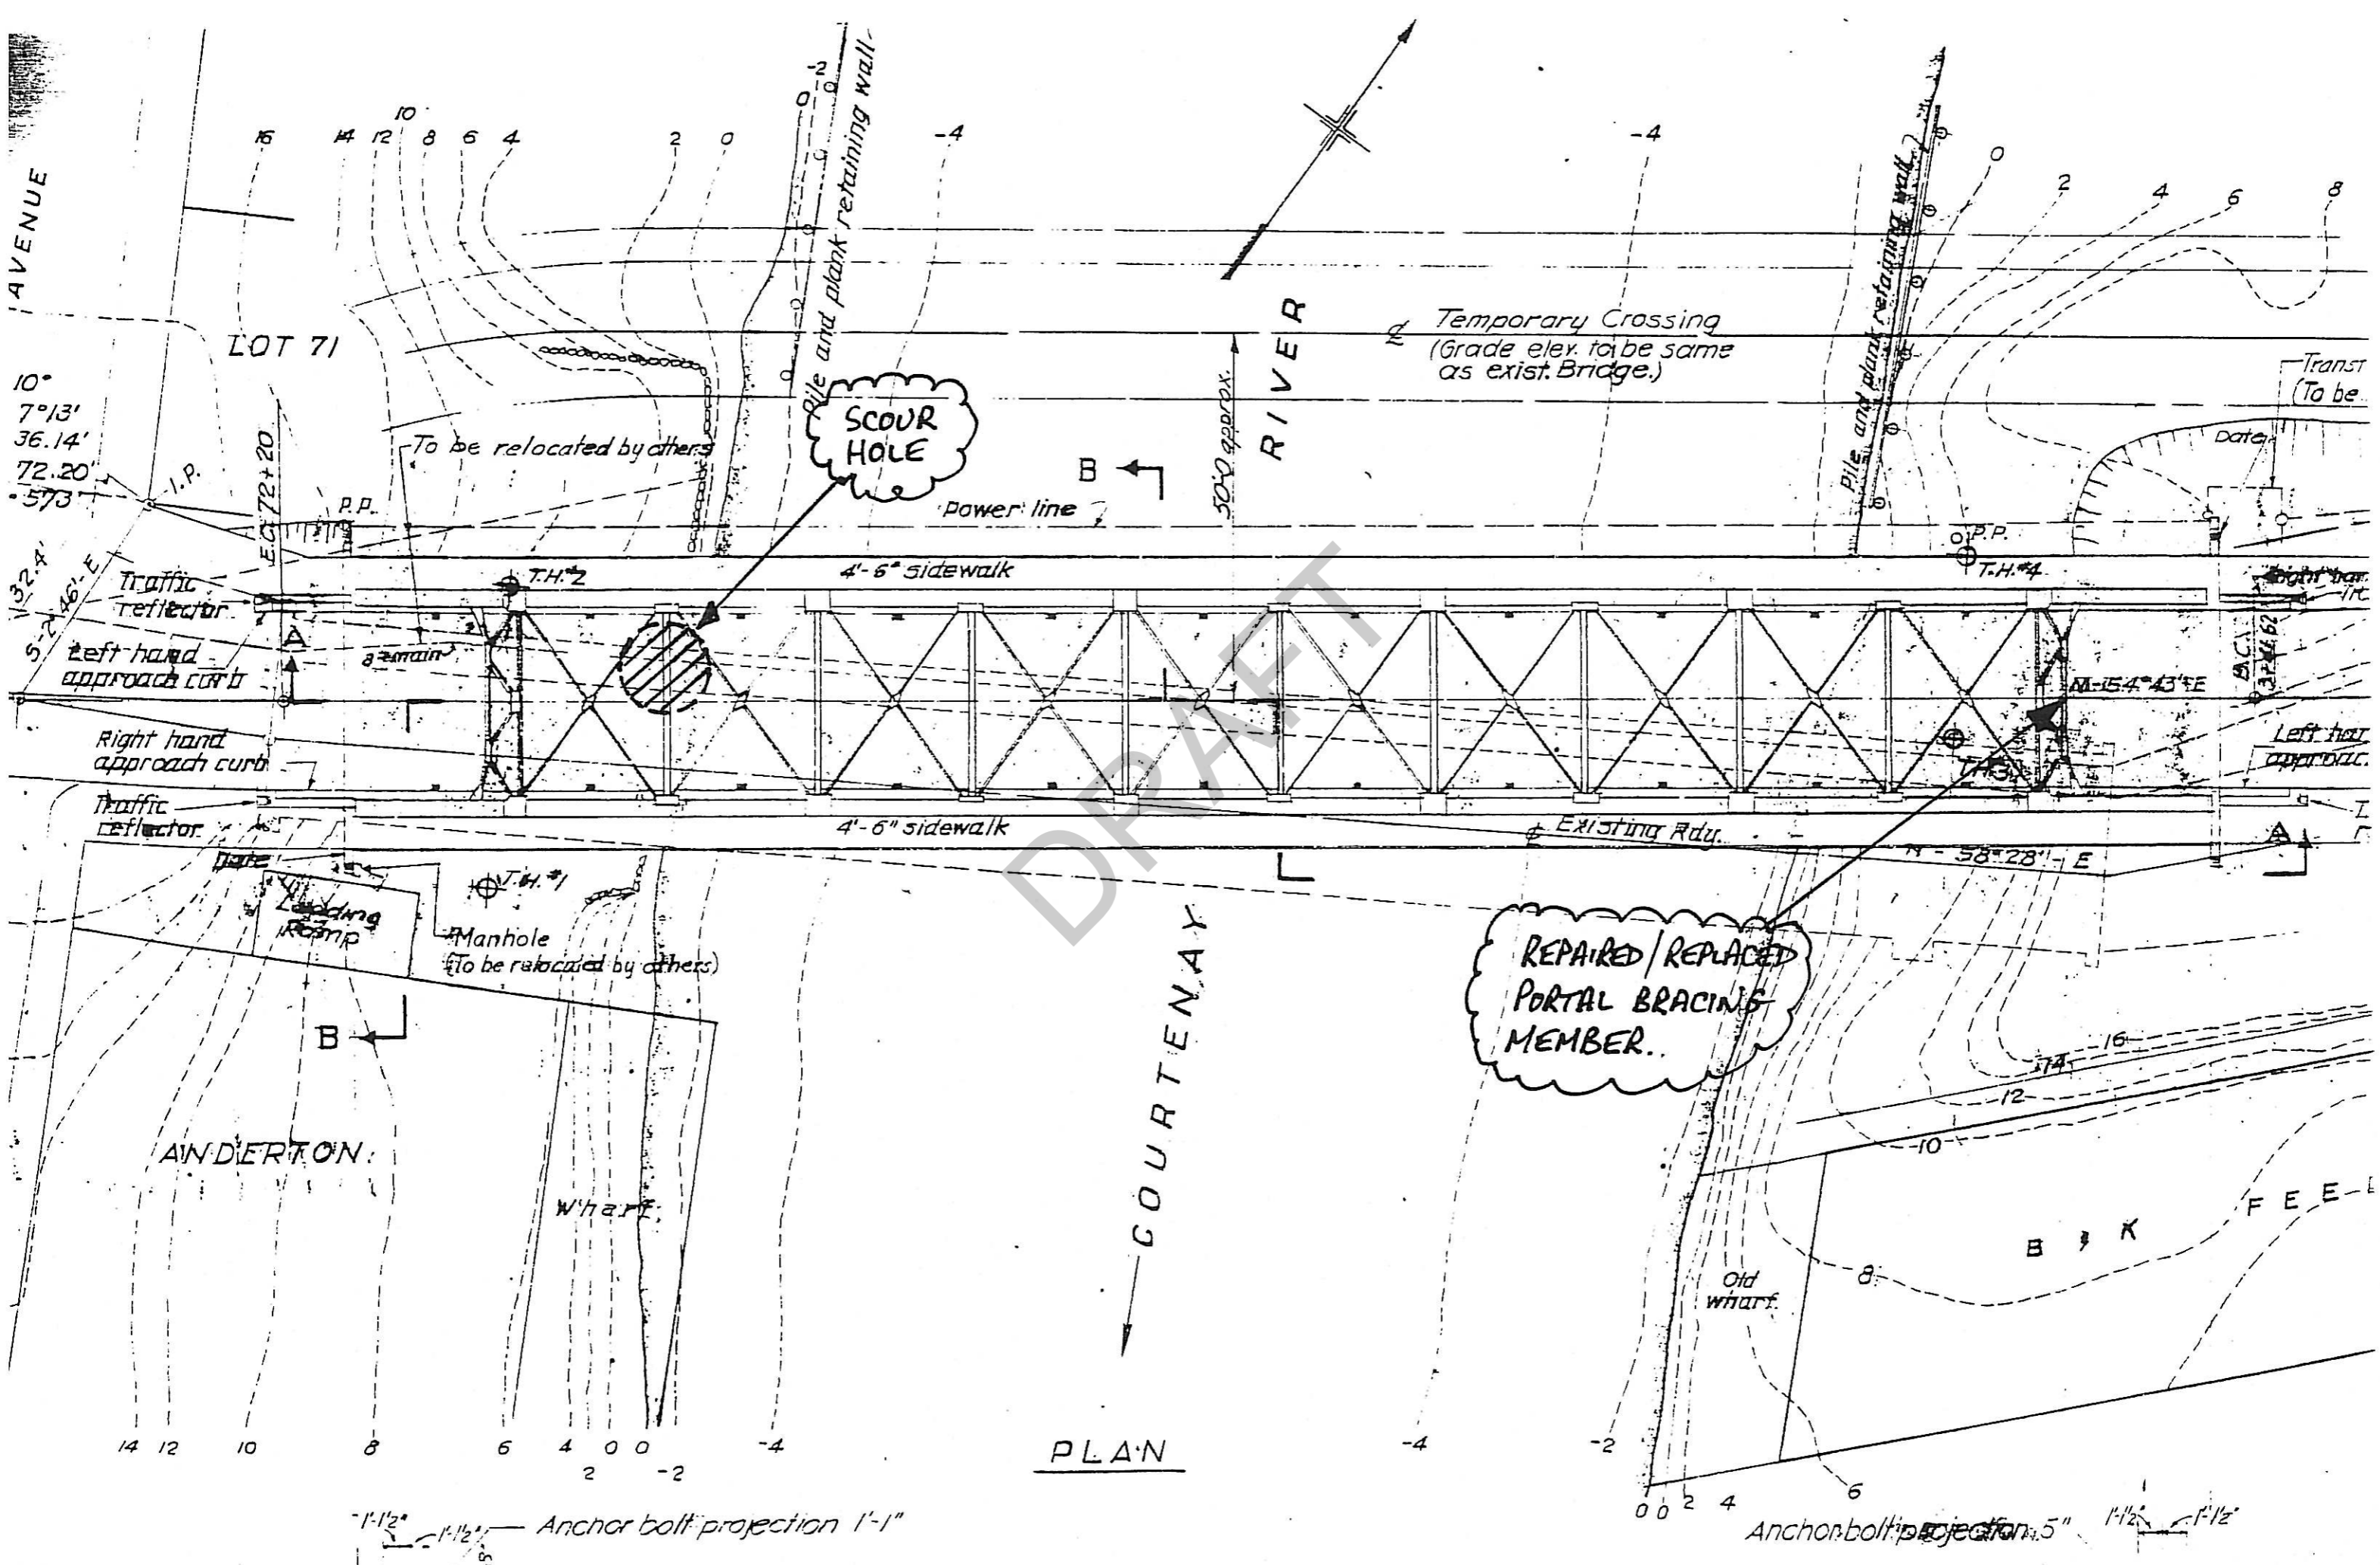
**NOTES:**  
Specific  
Loading  
Datum =

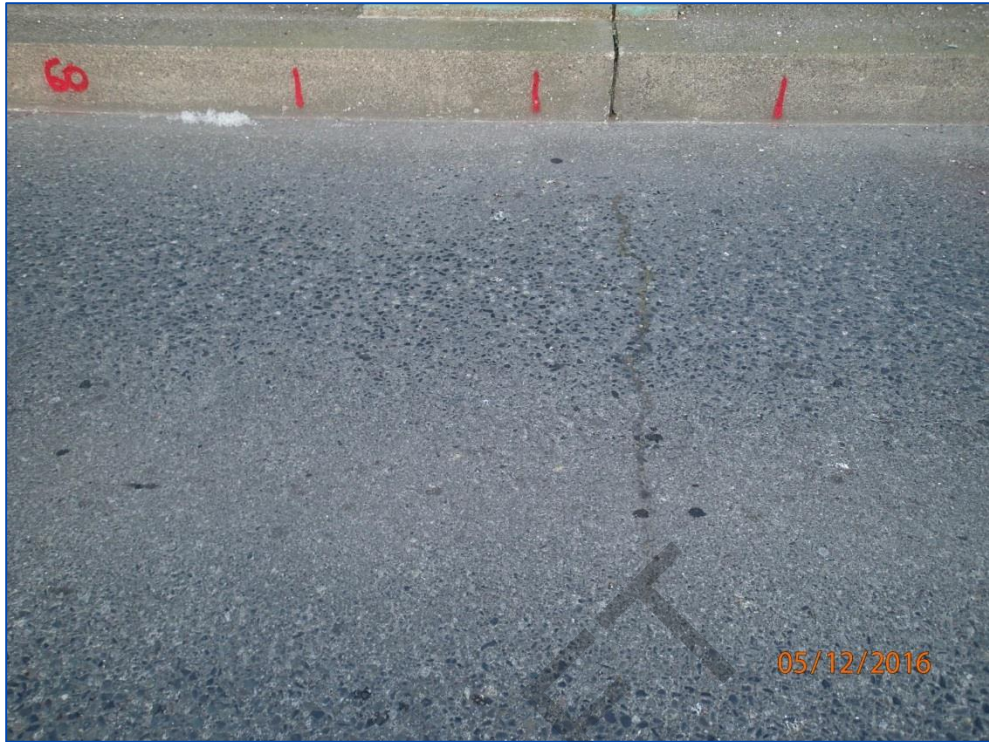
Photo 7: Transverse crack near chainage 58 m in eastbound lane.

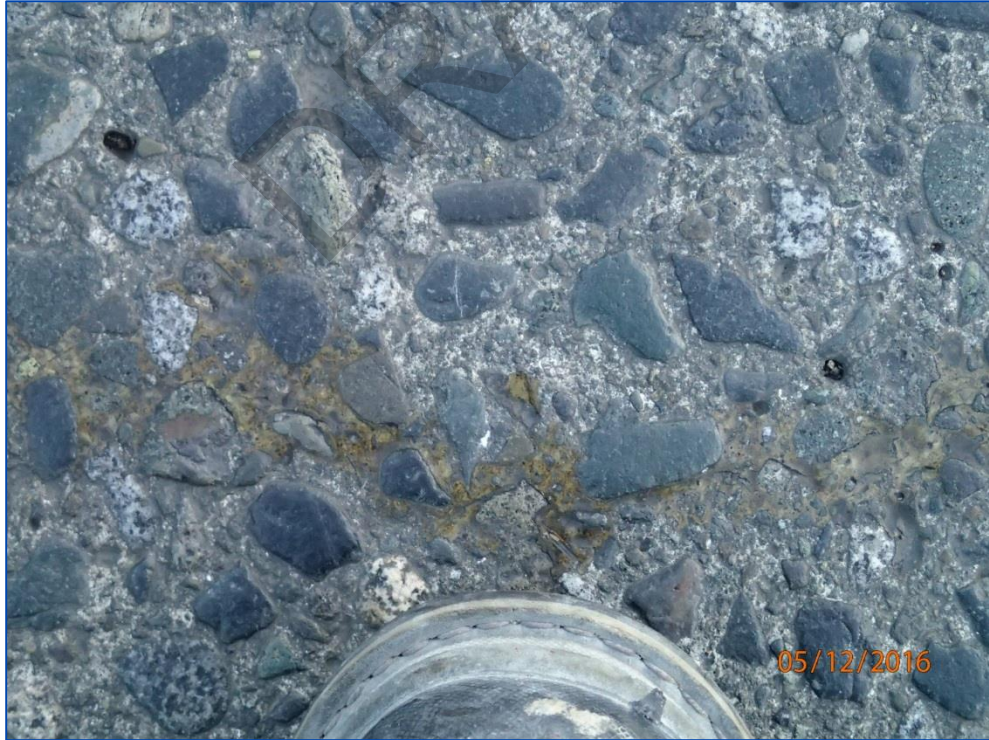
Photo 8: Close-up of a typical transverse crack in the eastbound lane with epoxy.

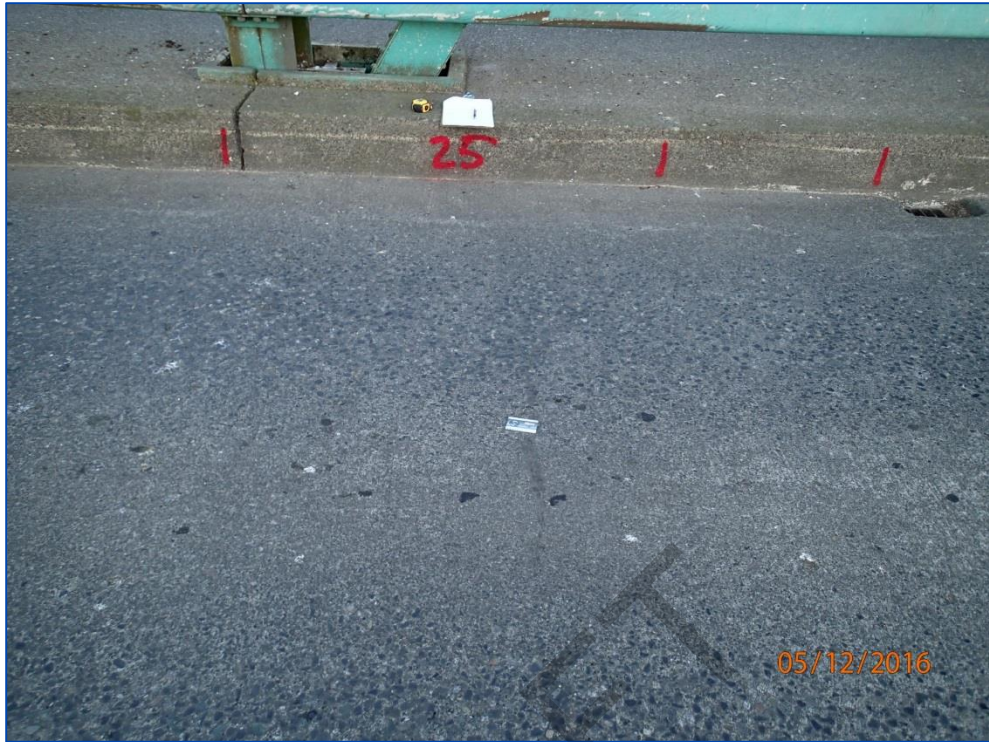
Photo 9: Partial width transverse crack near chainage 25 m in the eastbound lane.

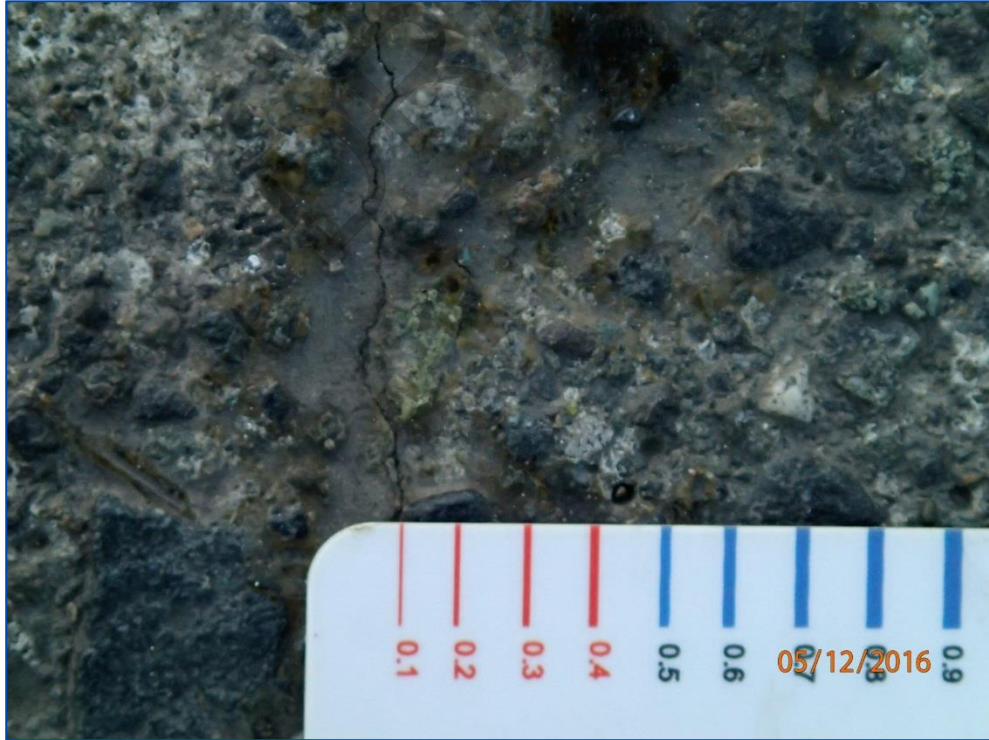
Photo 10: Close-up of Photo 9 showing 0.1 mm wide crack with failed epoxy.

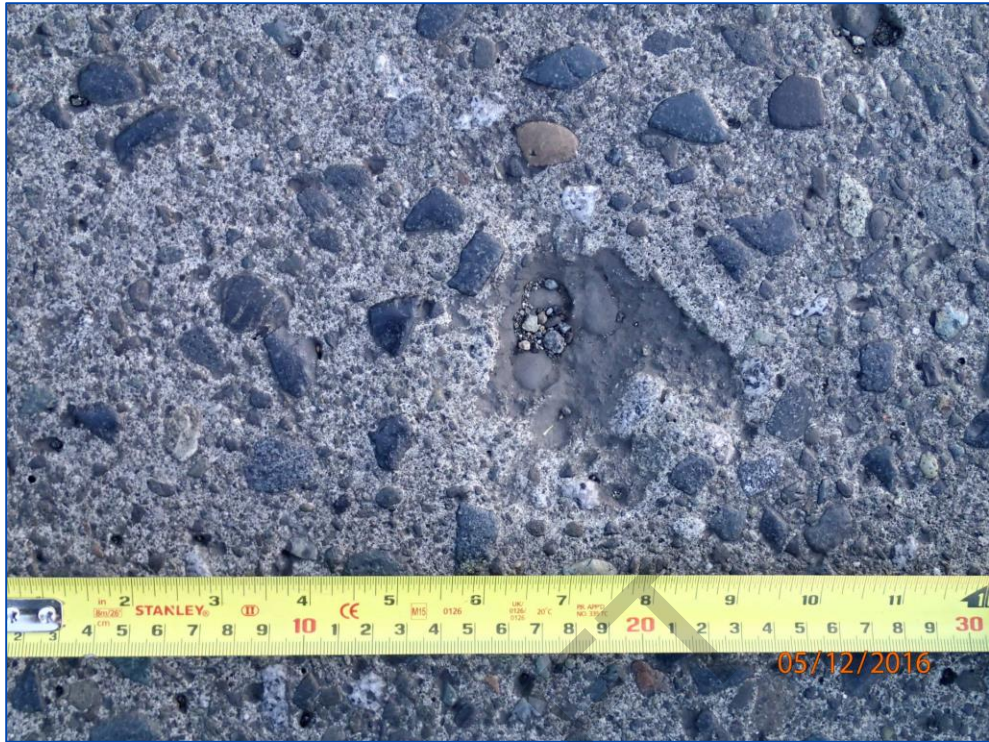
Photo 11: Minor pop out in the eastbound lane near the east end of the bridge.

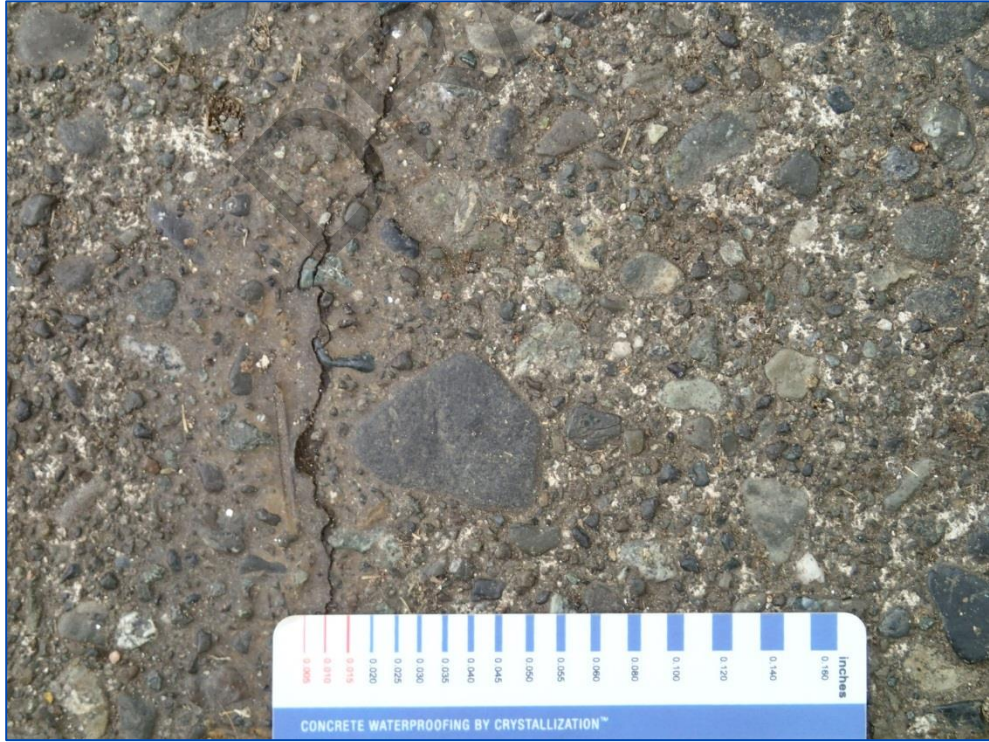
Photo 16: Close-up of Photo 15 showing 0.3 mm crack.

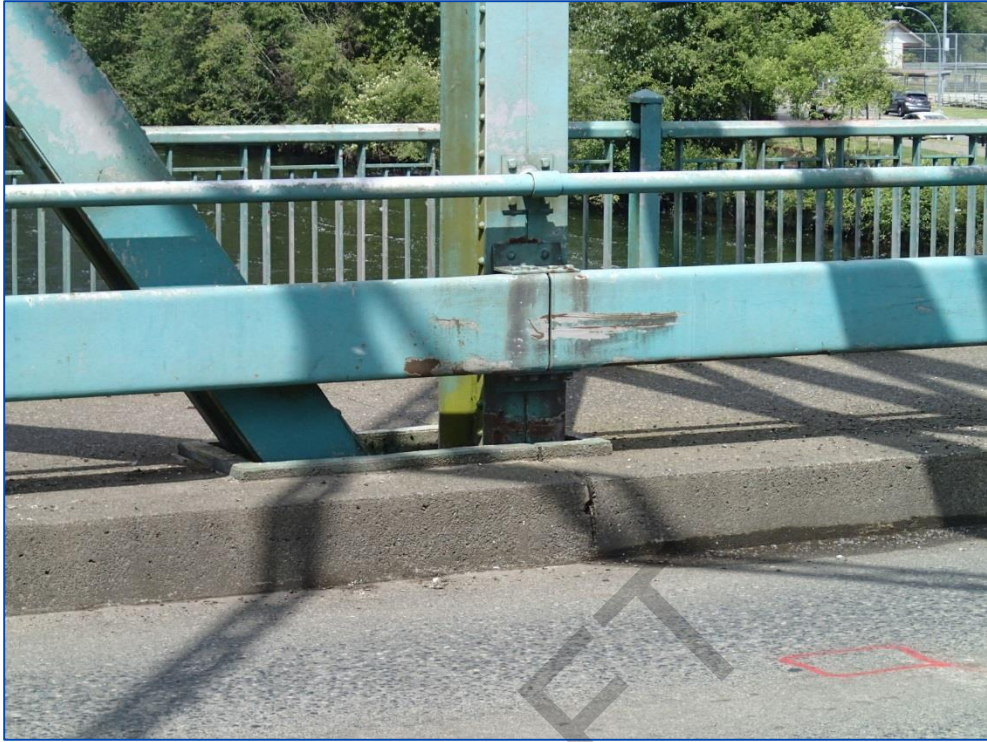
Photo 17: Minor impact damage to the north rail.

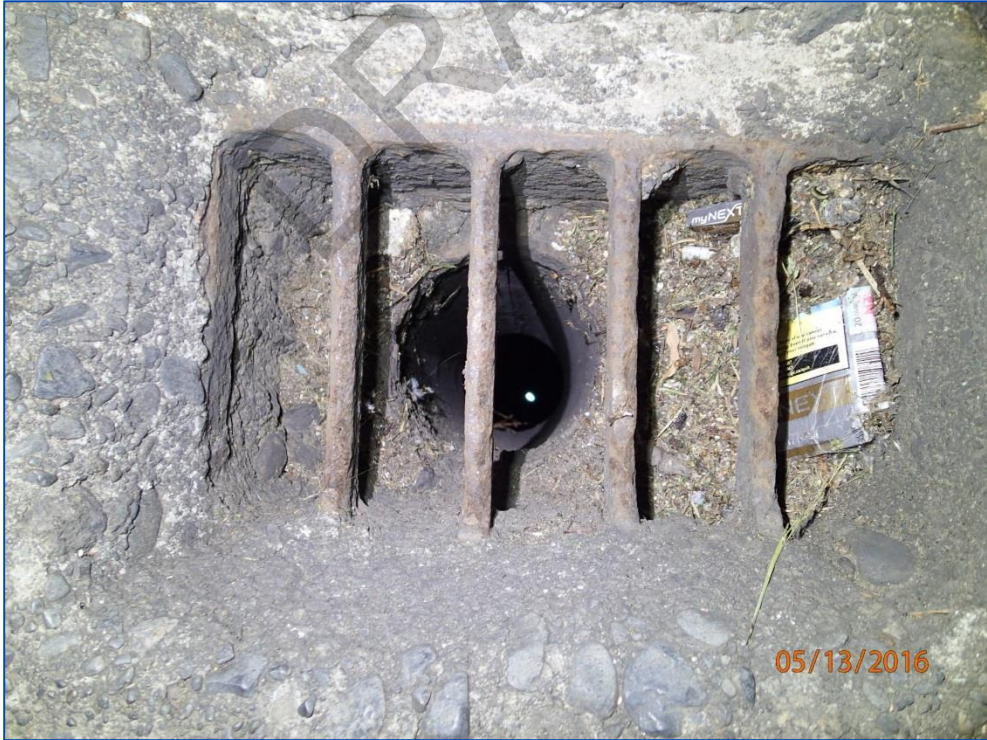
Photo 18: Condition of the drain (typical).

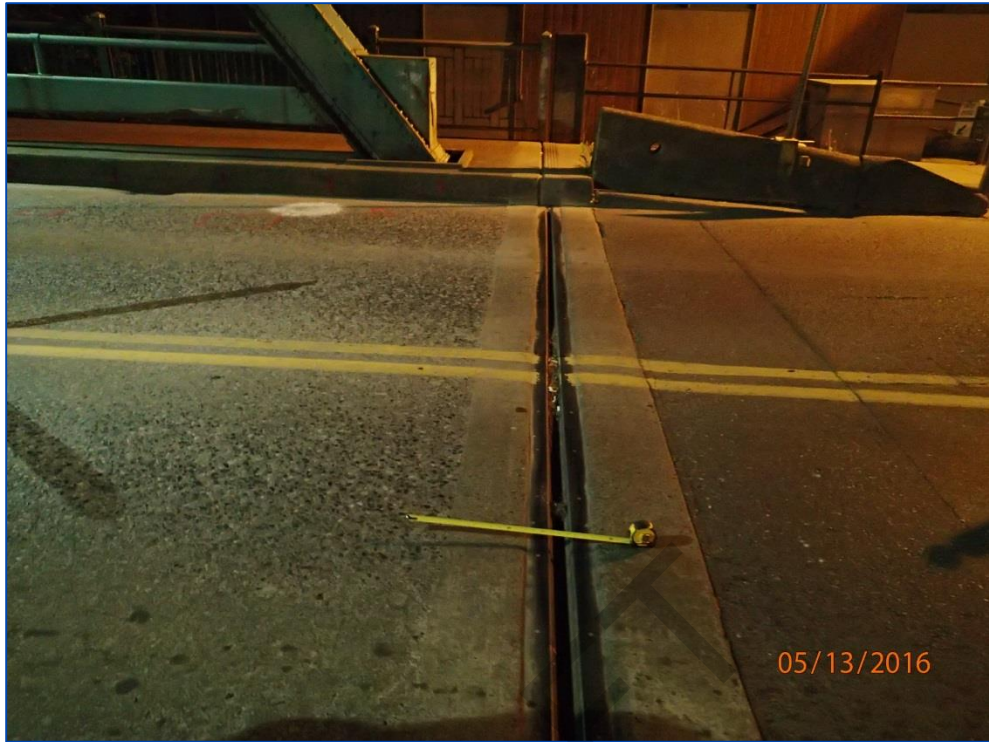
Photo 19: Expansion joint at the west abutment facing south.

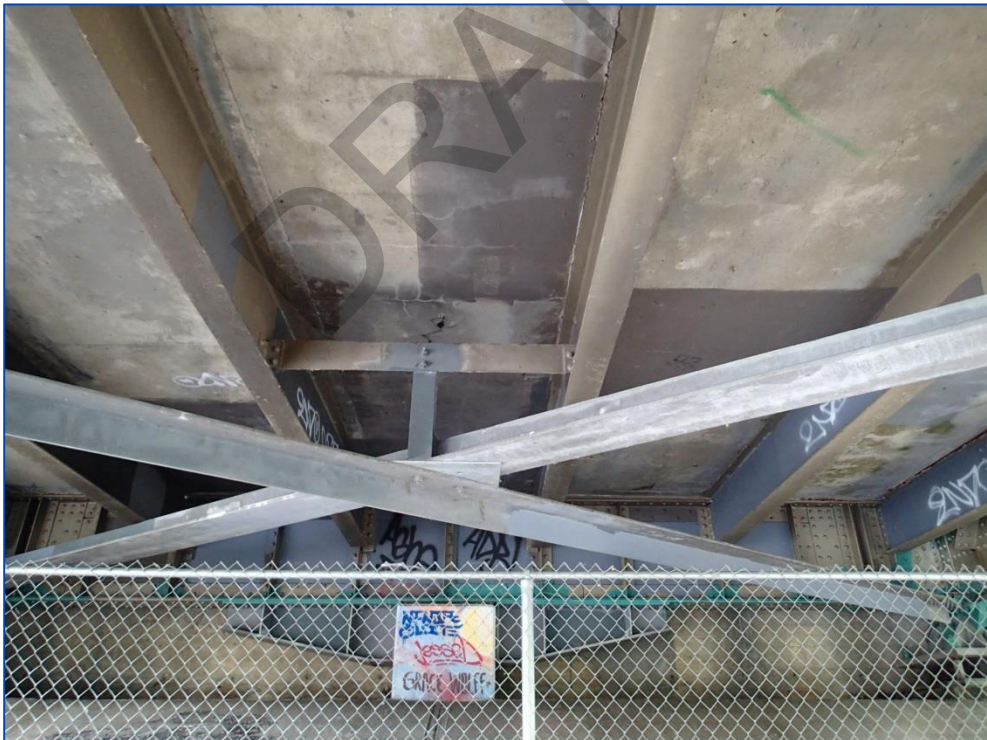
Photo 26: Soffit adjacent to the east abutment showing pattern cracking and efflorescence.

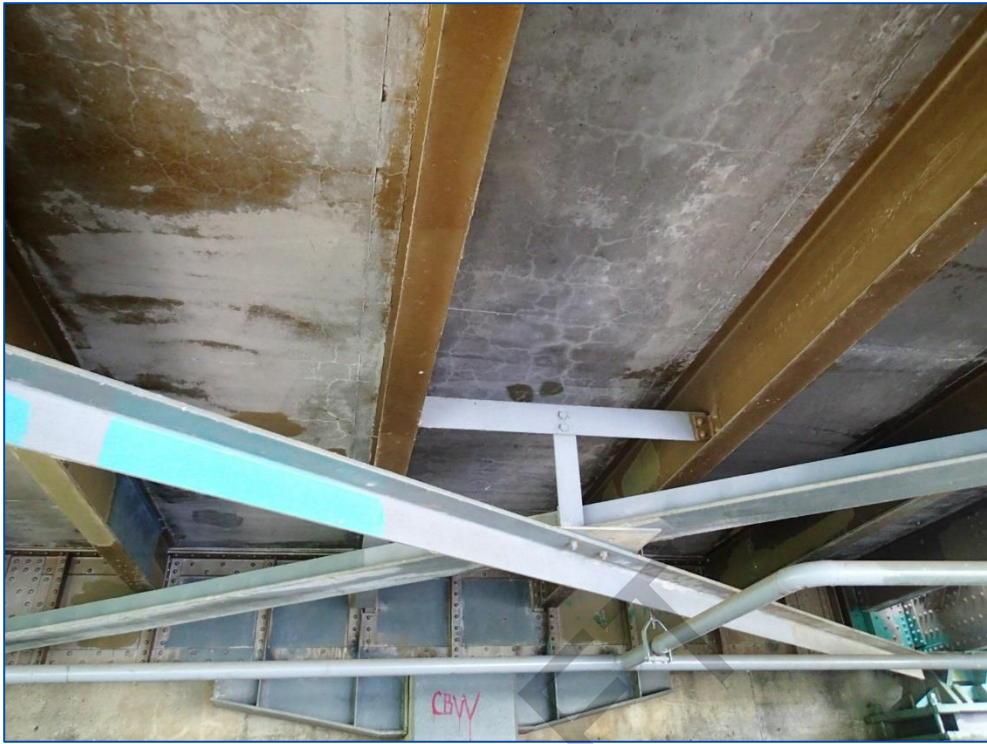
Photo 27: Soffit adjacent to the west abutment showing pattern cracking and efflorescence.

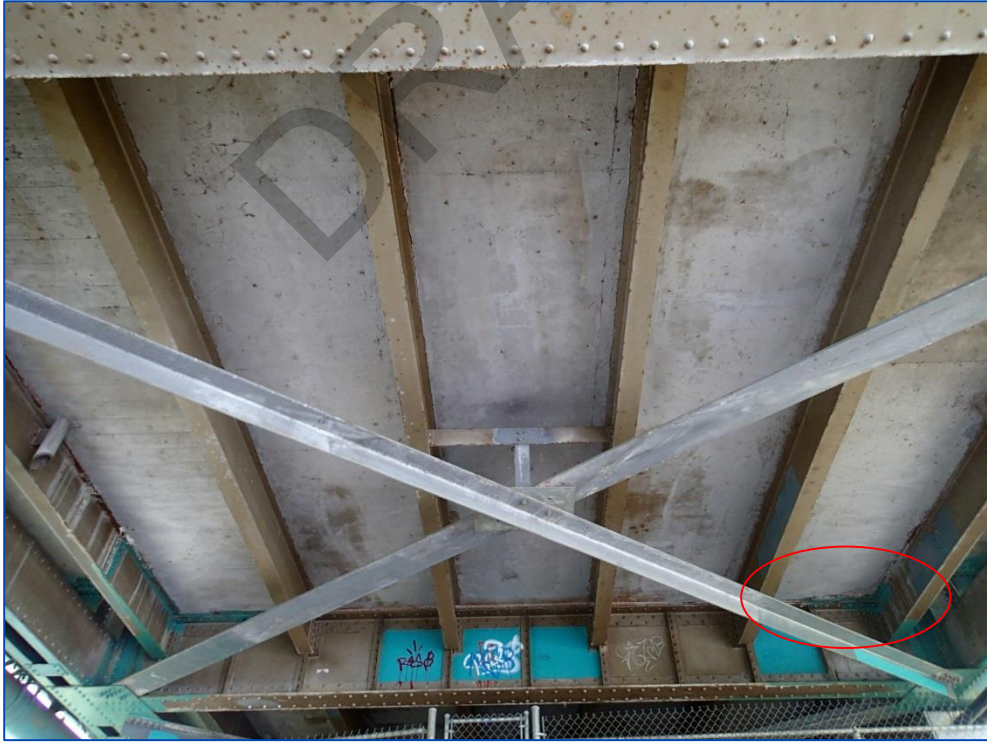
Photo 28: Soffit near the west abutment showing pattern cracking.

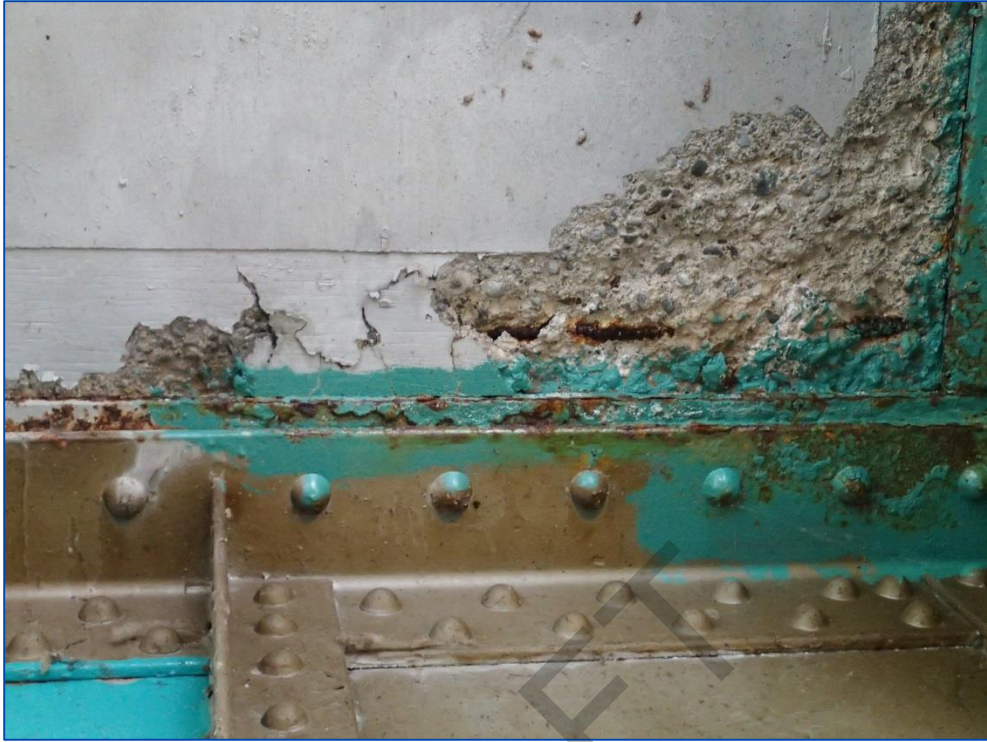
Photo 29: Spall due to low cover corroding rebar (Close-up of Photo 28).

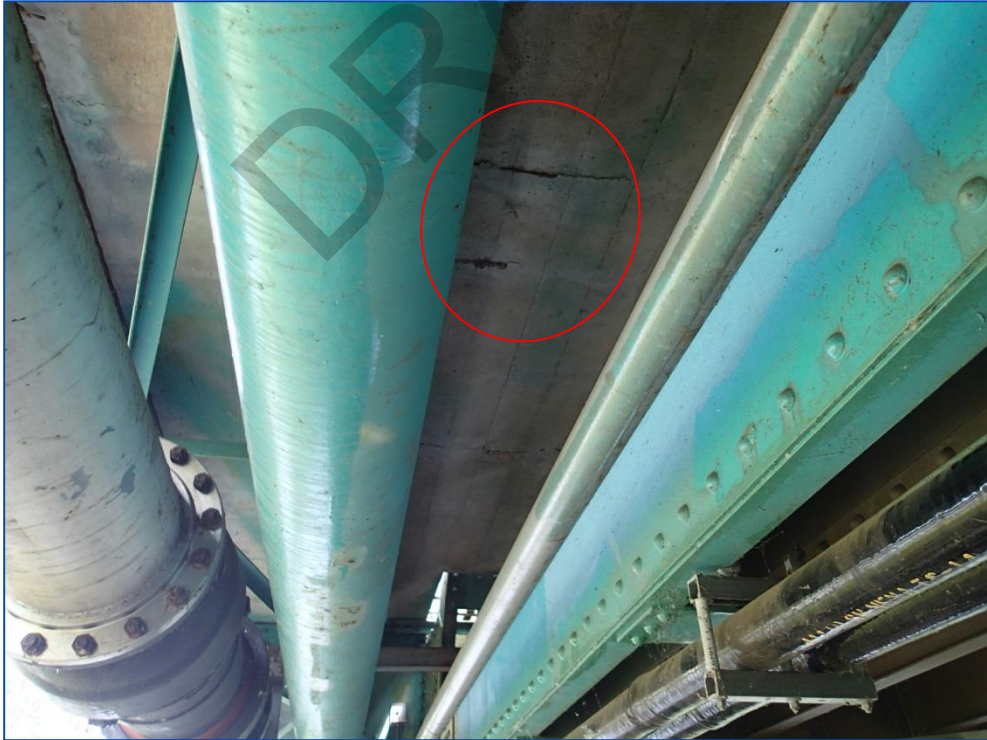
Photo 30: Spalls due to low cover corroding rebar at the north sidewalk soffit adjacent the west abutment.

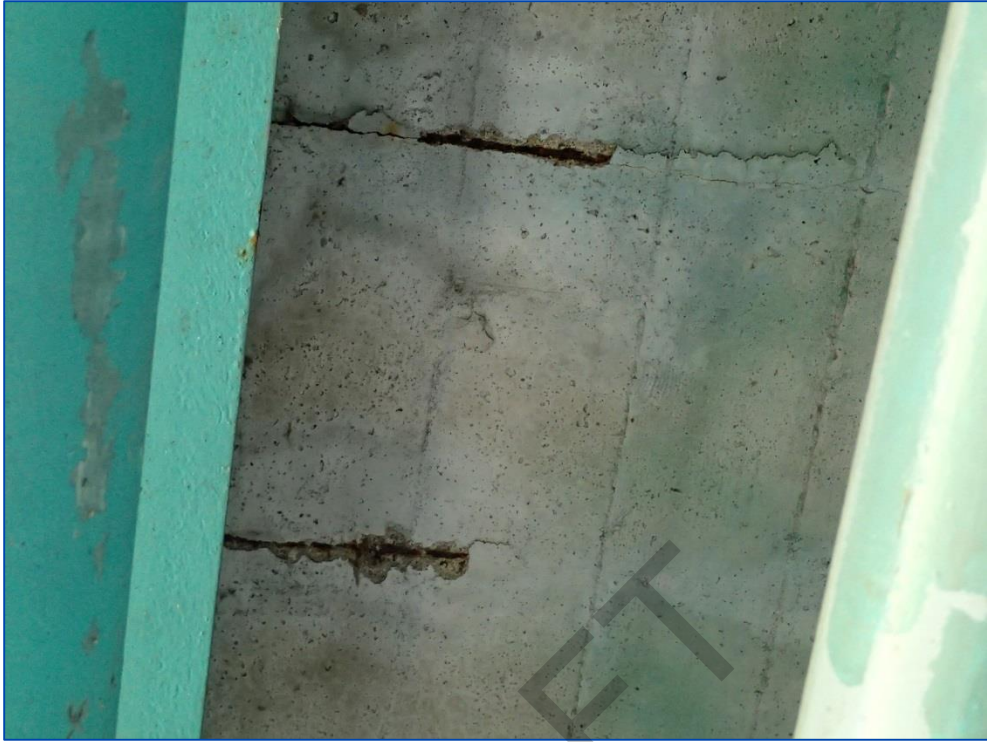
Photo 31: Close-up of Photo 30.

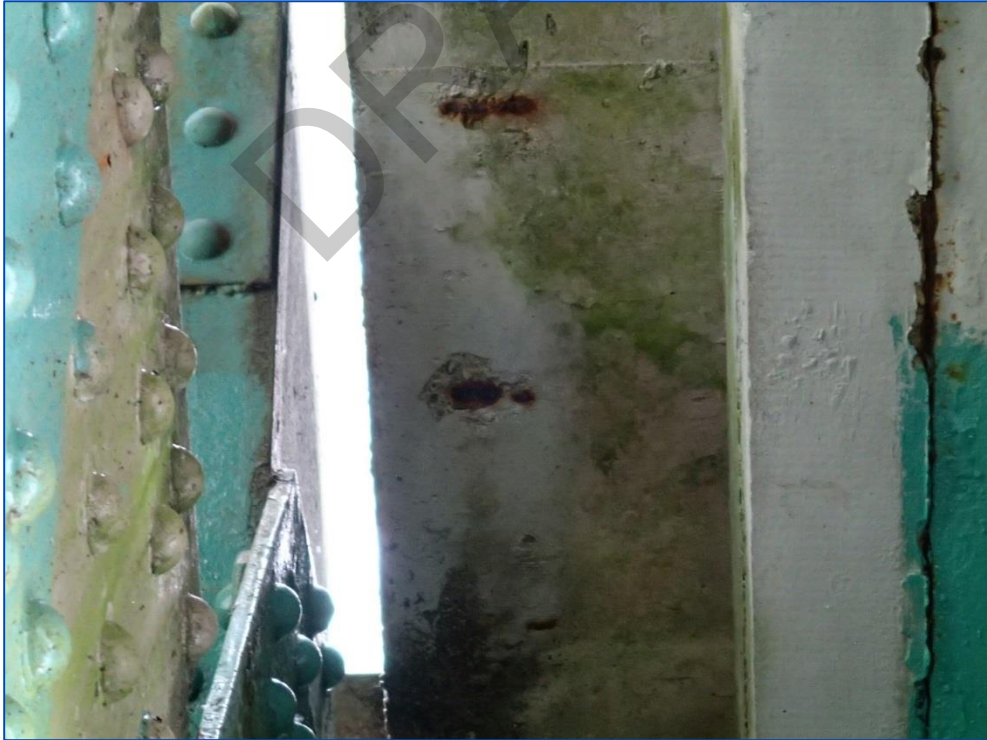
Photo 32: Low cover corroding rebar at the south curb soffit near the east abutment.

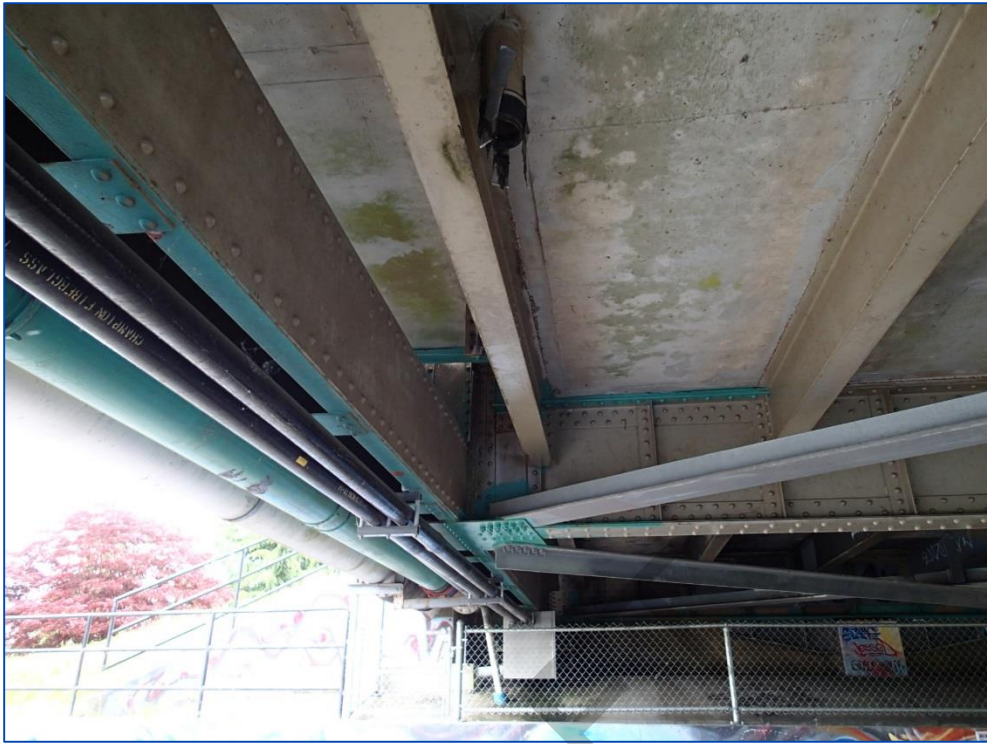
Photo 33: Northern half of deck soffit and sidewalk near the east abutment.

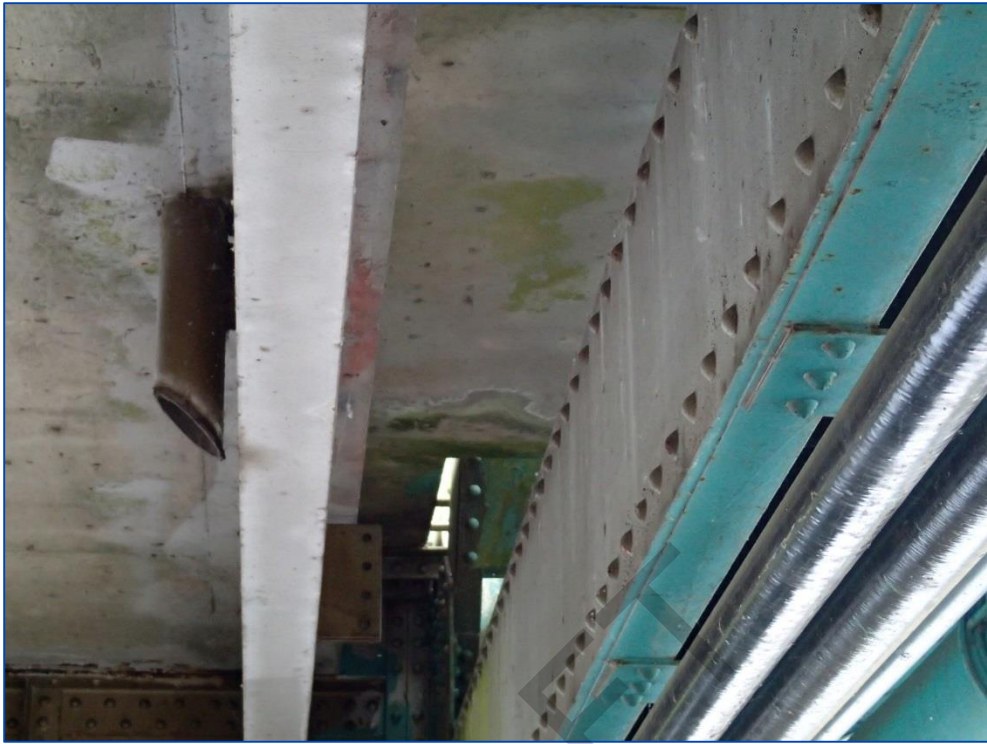
Photo 35: Leakage staining in the curb soffit adjacent to the vertical steel members (typical).

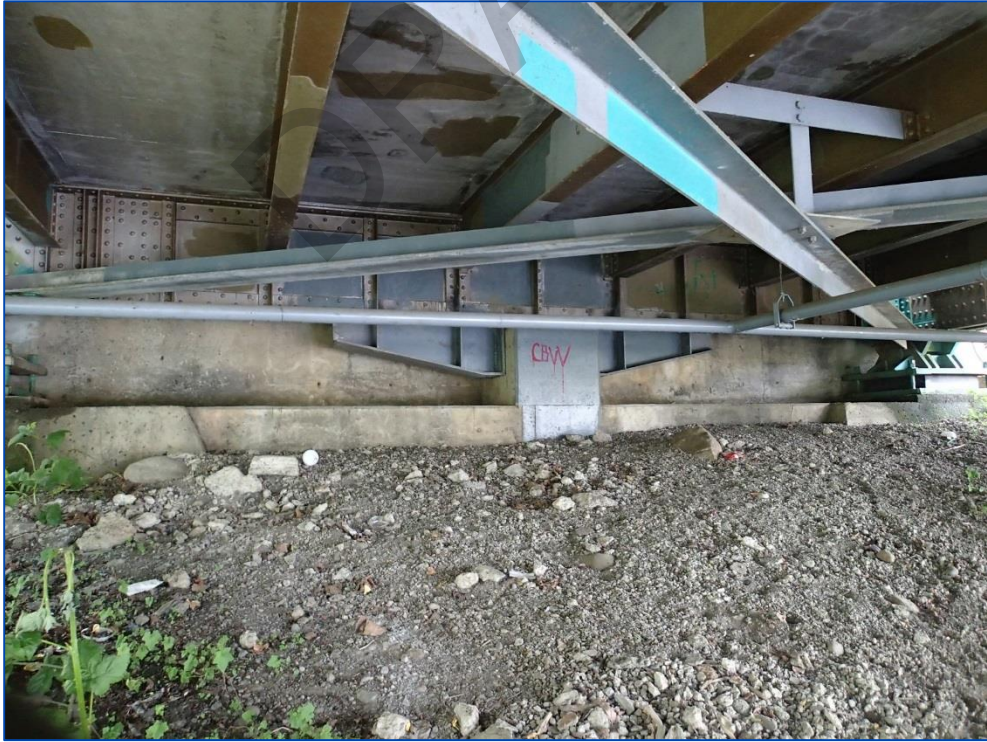
Photo 36: General view of the west abutment.

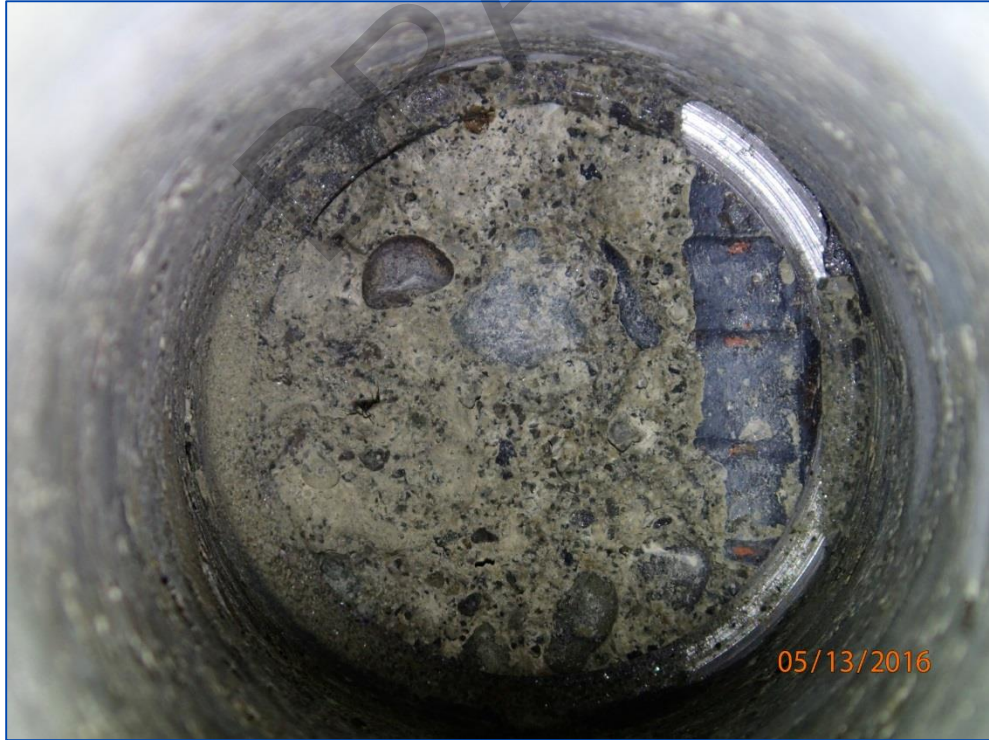
Photo 42: Condition of bottom mat longitudinal bar at Core 4.

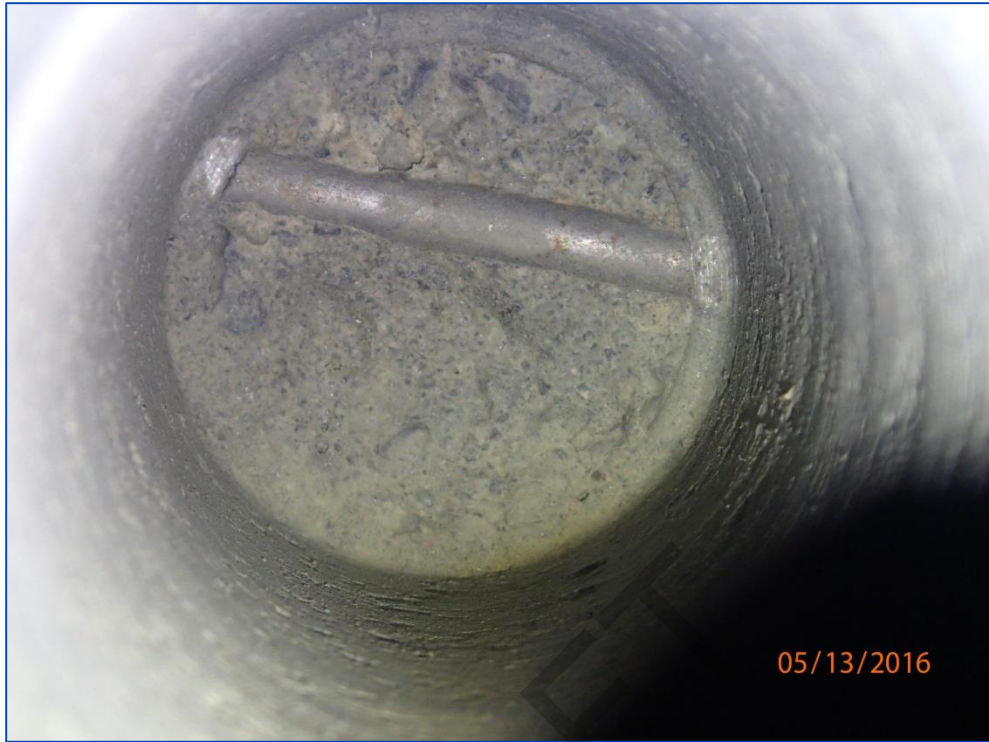
Photo 43: Condition of transverse wire mesh at Core 6.

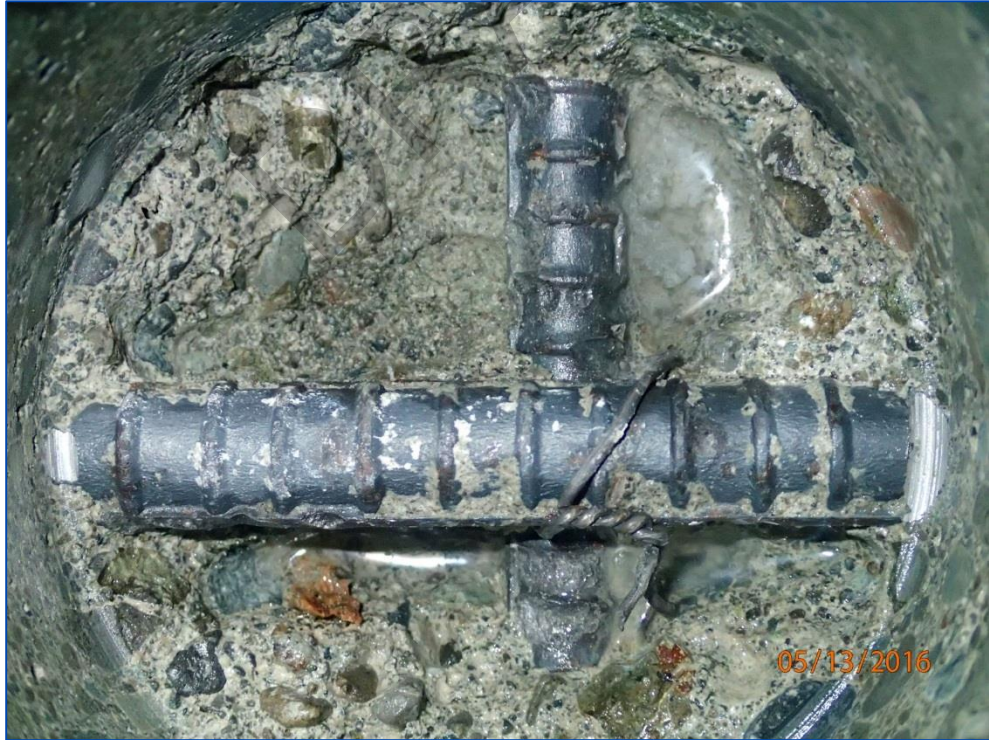
Photo 44: Condition of top mat of rebar at Core 8.

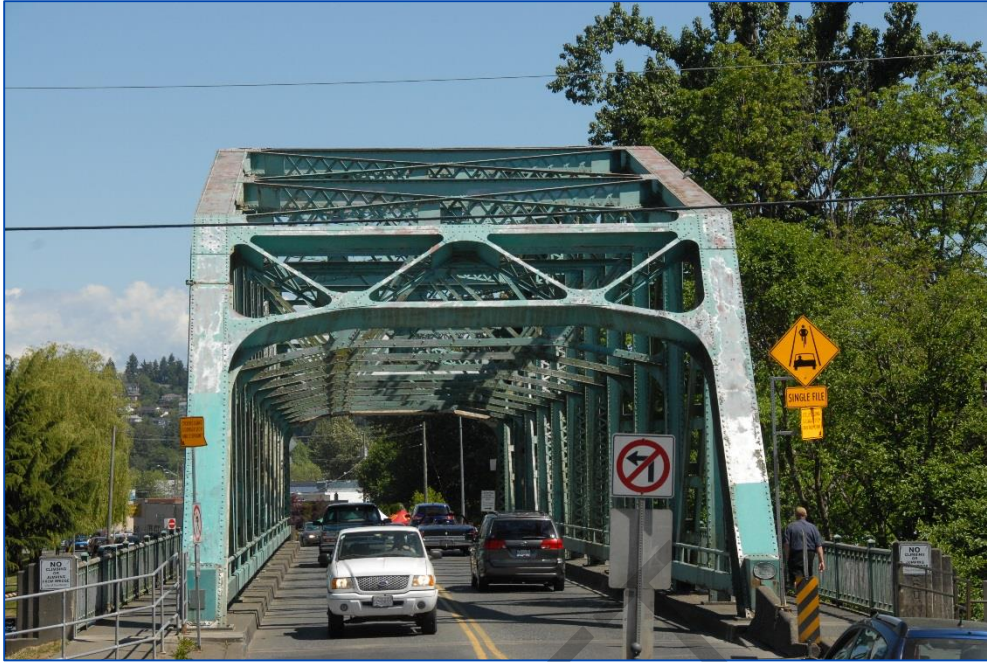
Photo 45: General view of south end.

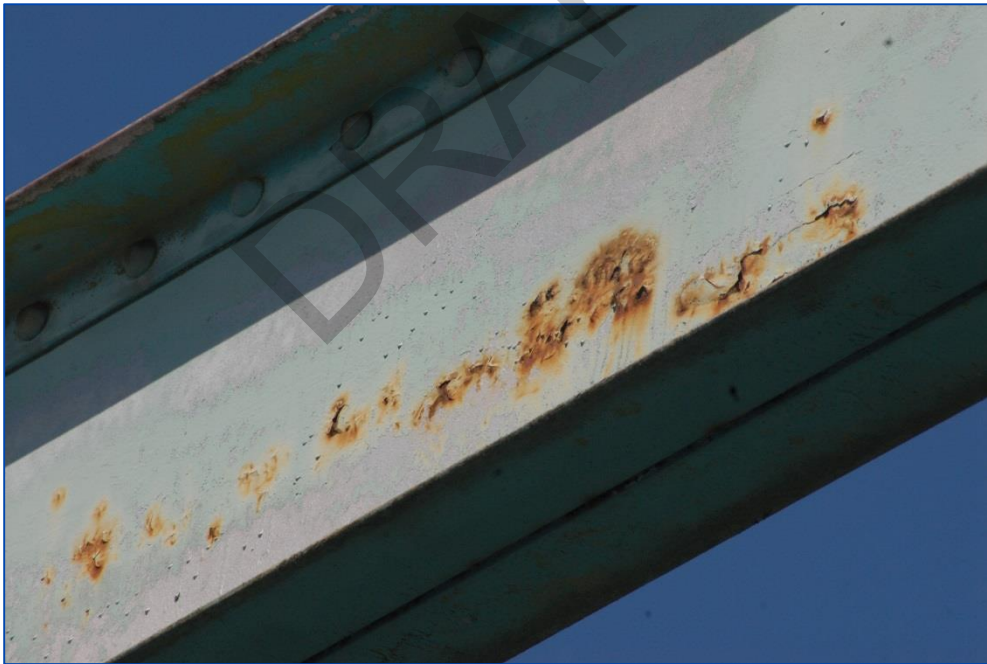
Photo 49: Close-up view of coating failure on webs of built up elements
