## Addendum 2

December 10, 2020

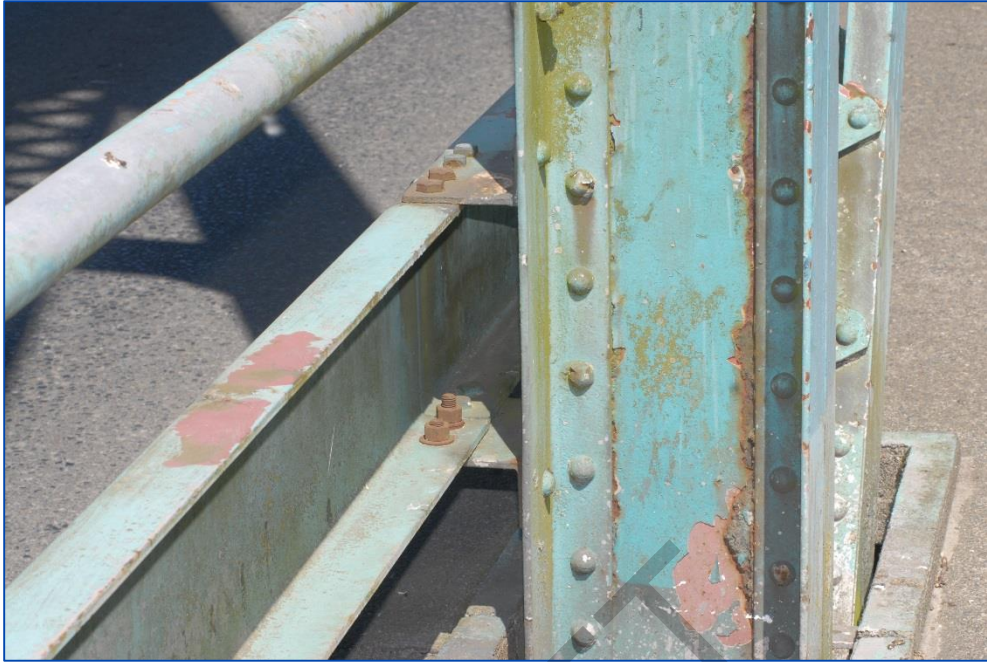
Photo 50: General view of truss "hanger" at approximately mid-span on the west (upstream) side. Note the corrosion at the toe of the angle.

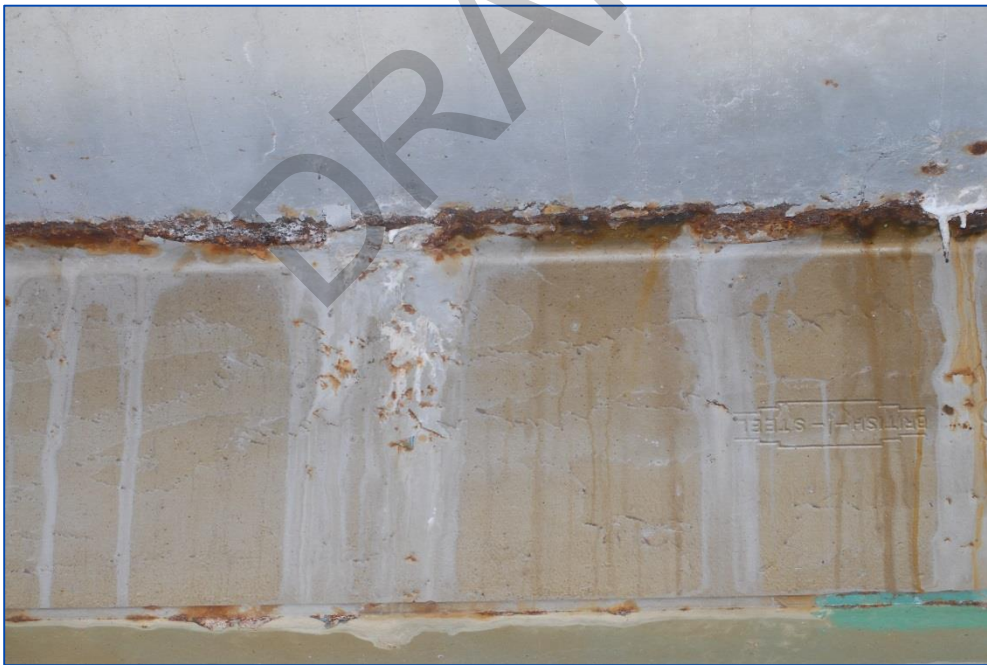
Photo 51: Close-up view of typical stringer showing corrosion of flange edge at concrete soffit.

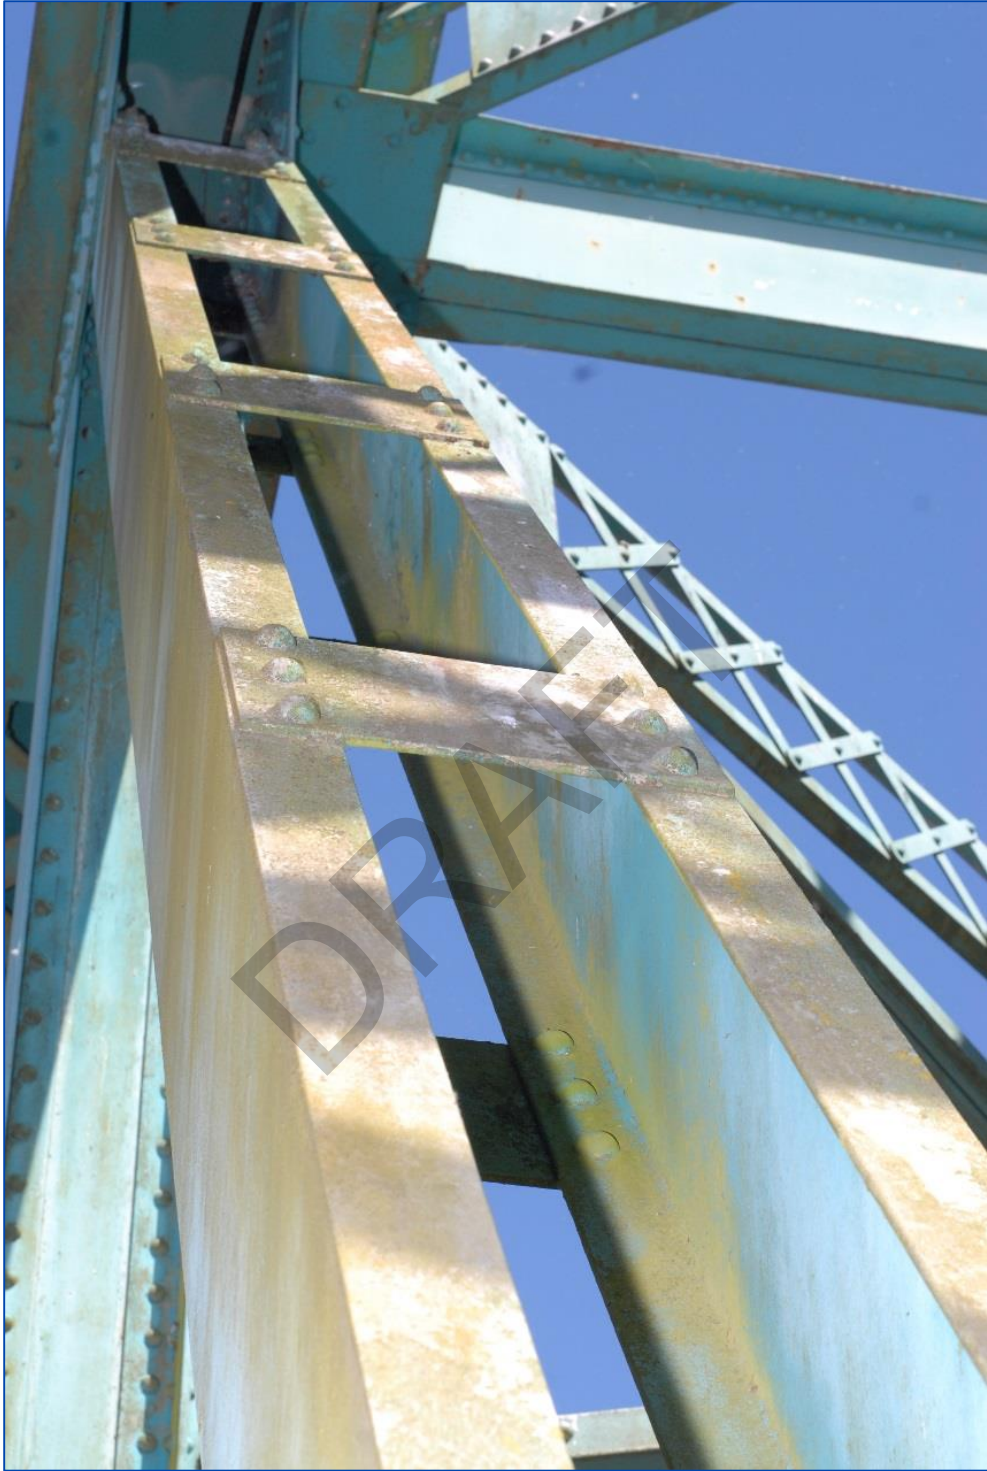
Photo 52: Oblique view of diagonal bracing in truss, east side.

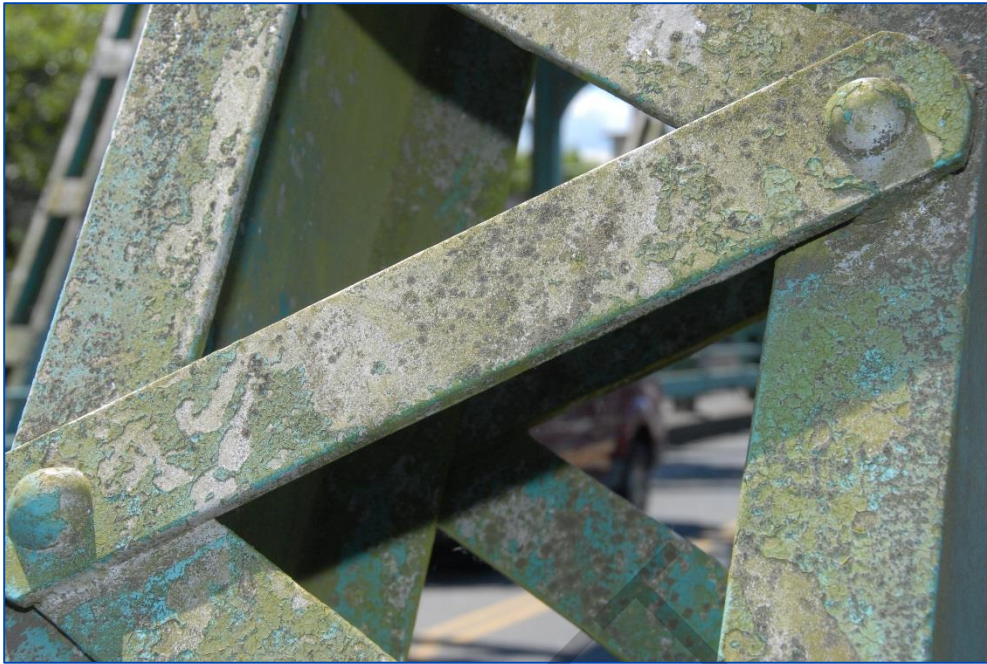
Photo 54: Close-up view of lattice in Photo 9, showing failure of green vinyl topcoat.

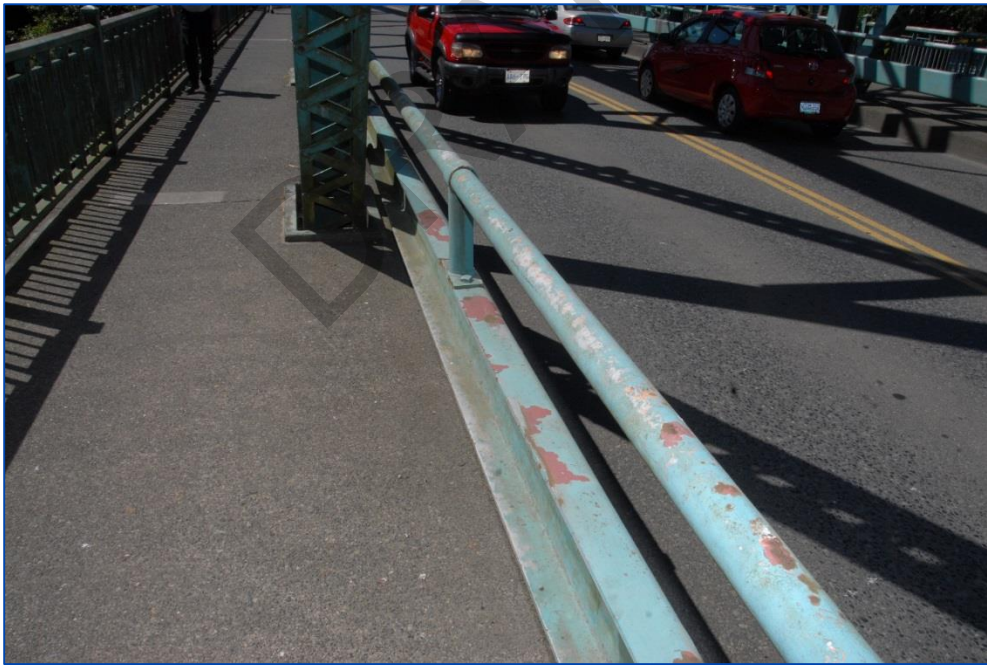
Photo 55: Oblique view of traffic lane railing/rub rail as seen looking approximately south.
