CITY OF
COURTENAY

November 20, 2019

**RIVER AND STREAM CHANNEL RECONNAISSANCE AND
GEOTECHNICAL STABILITY ASSESSMENT
COURTENAY, B.C.**

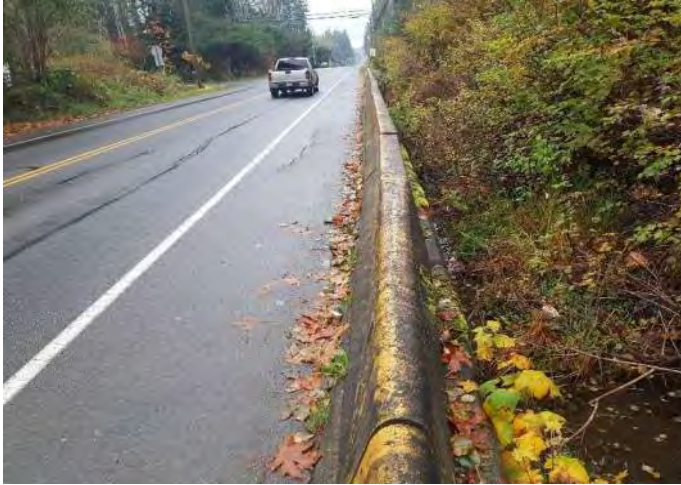
Photo 1, Roadway with creek, cracking on pavement visible.

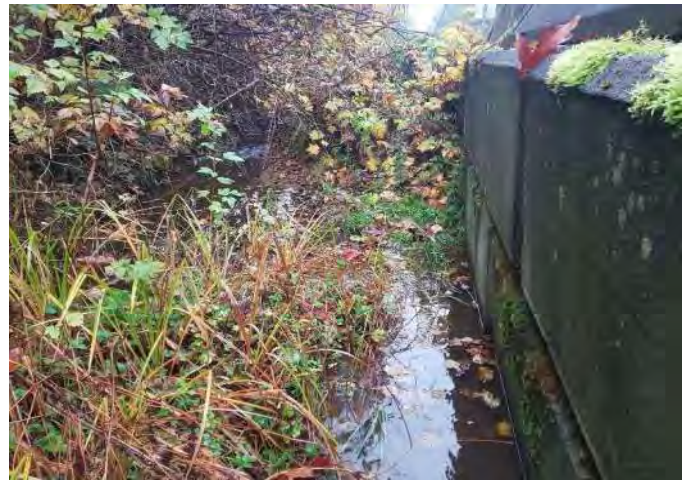
Photo 2, Lock block wall making up left bank of creek.

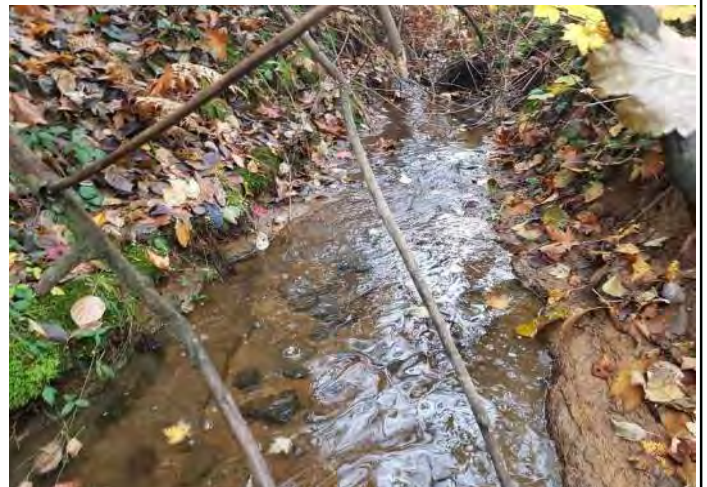
Photo 4, glacial soils exposed in channel base.

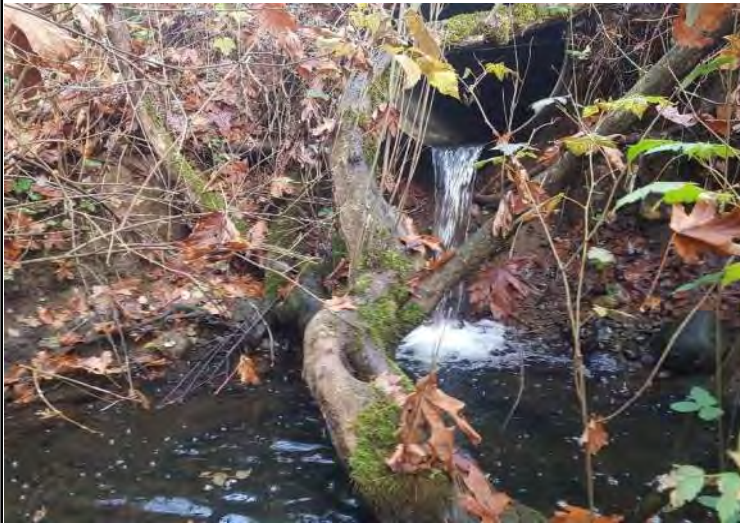
Photo 5, Culvert outlet with 1.5m drop into pool, erosion is visible underneath culvert.

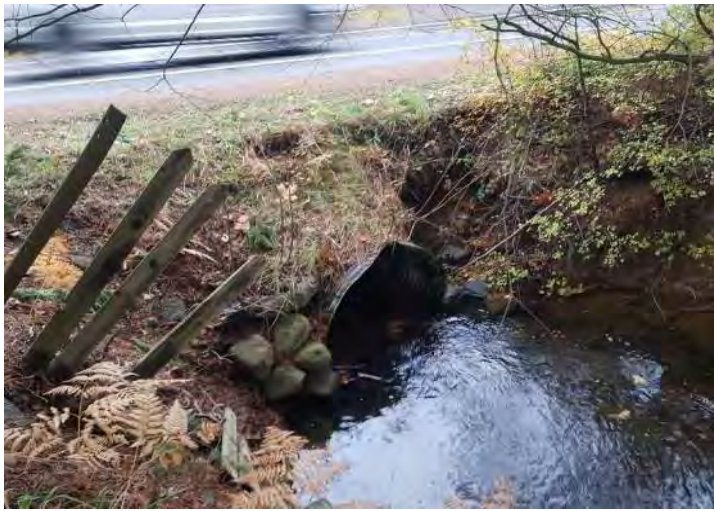
Photo 5 , Downstream culvert outlet, erosion visible on left bank.

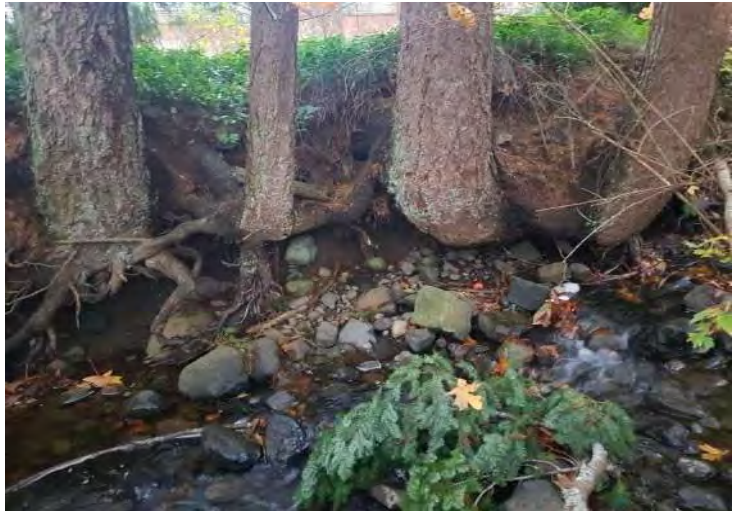
Photo 6, Large trees with visible undermining.

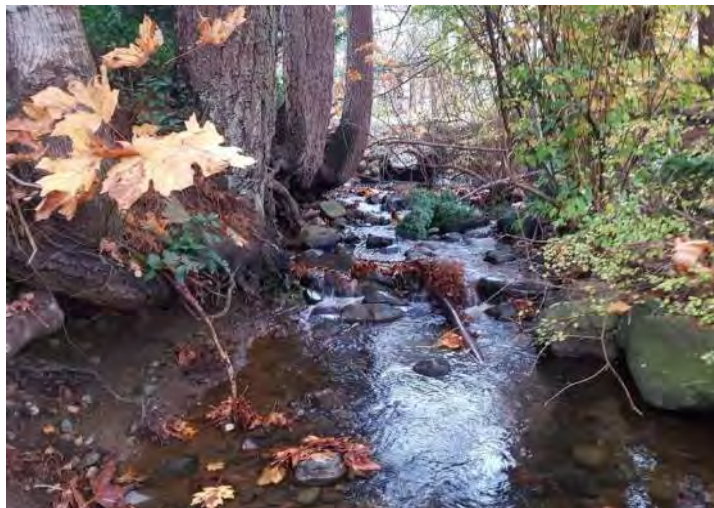
Photo 7, Downstream of culvert, 4 large trees with undermining erosion visible on right bank.

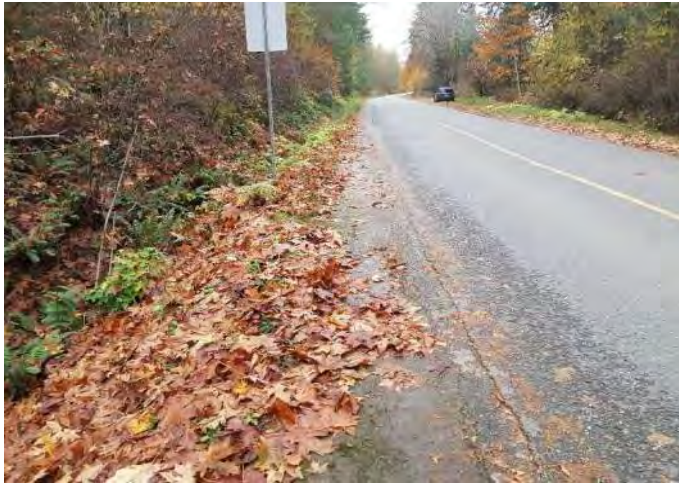
Photo 1, Upstream embankment showing pavement cracking.

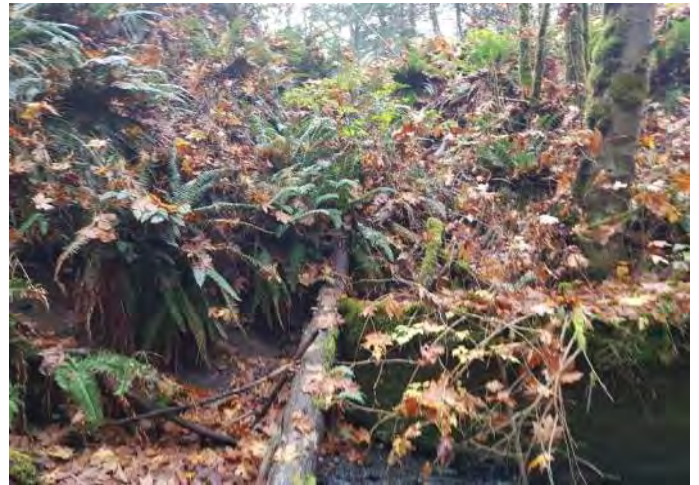
Photo 2, Upstream left bank showing mild erosion.

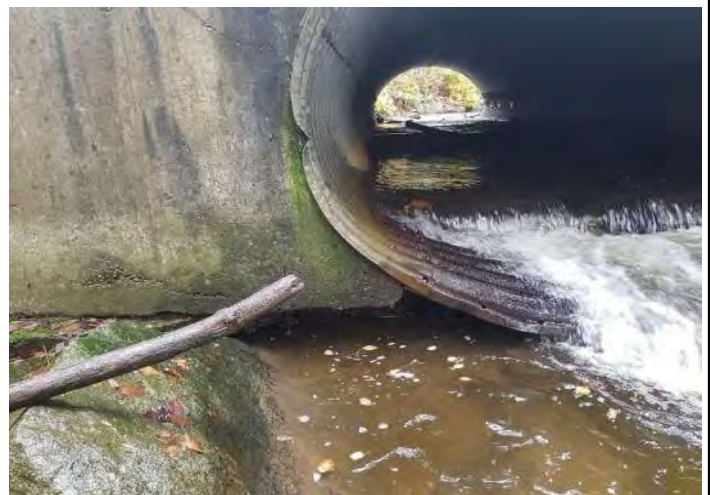
Photo 4, Erosion undermining culvert headwall structure to right of outlet.

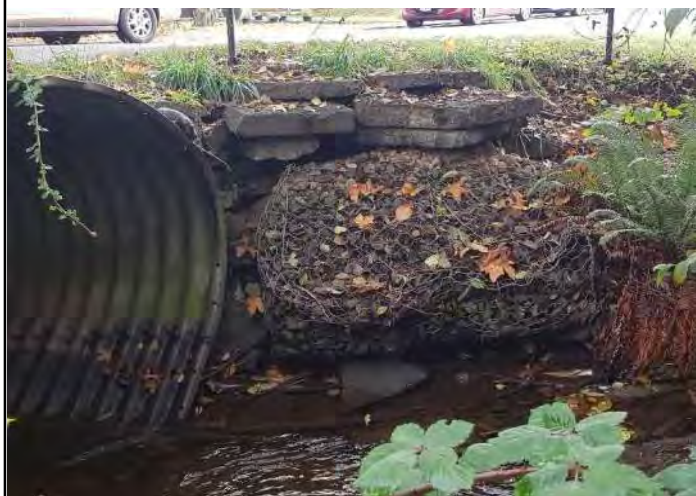
Photo 3, Upstream of culvert, close up of overturning gabion on the right bank.

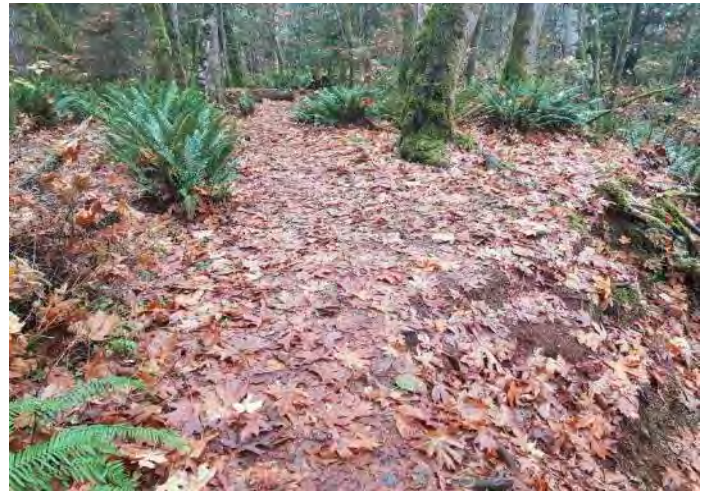
Photo 2, old trail (before relocated) at crest of bank where collapsed.

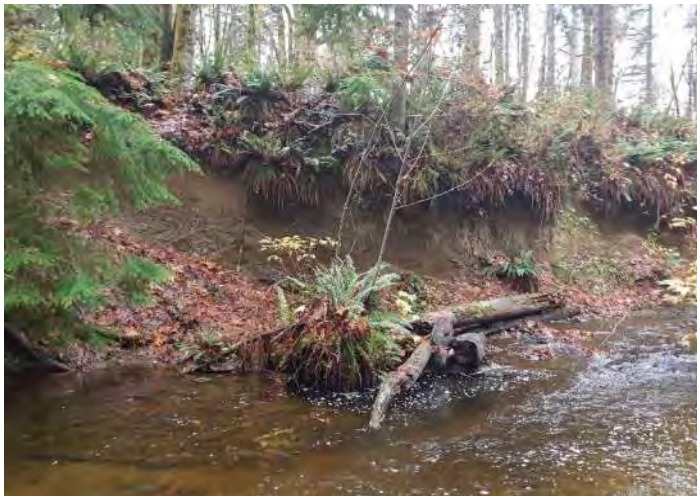
Photo 3, Right bank erosion with undermined crest, exposed clay visible.

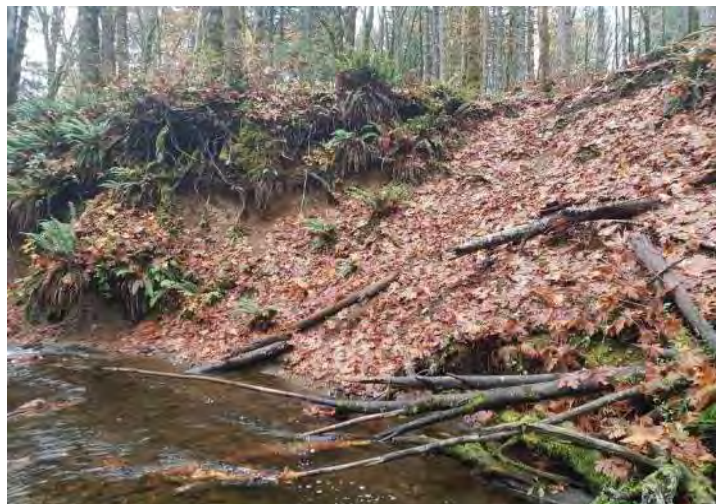
Photo 4, Right bank erosion. Collapsed crest at right side of photo.

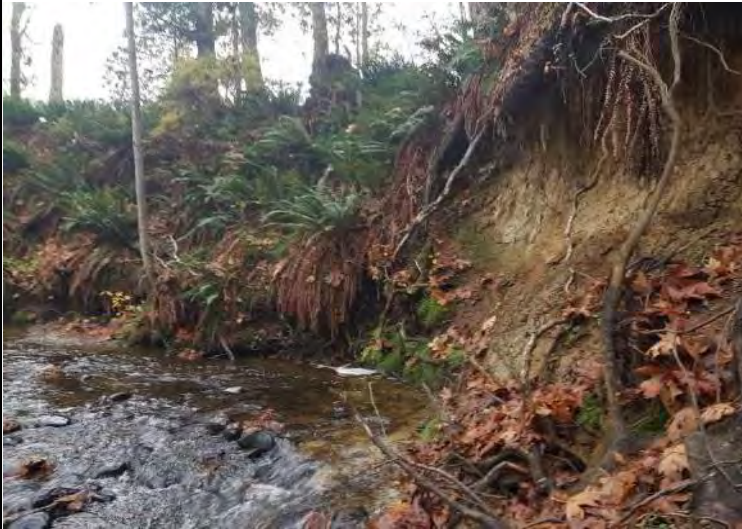
Photo 1, Left bank with erosion and undermining of tree roots visible.

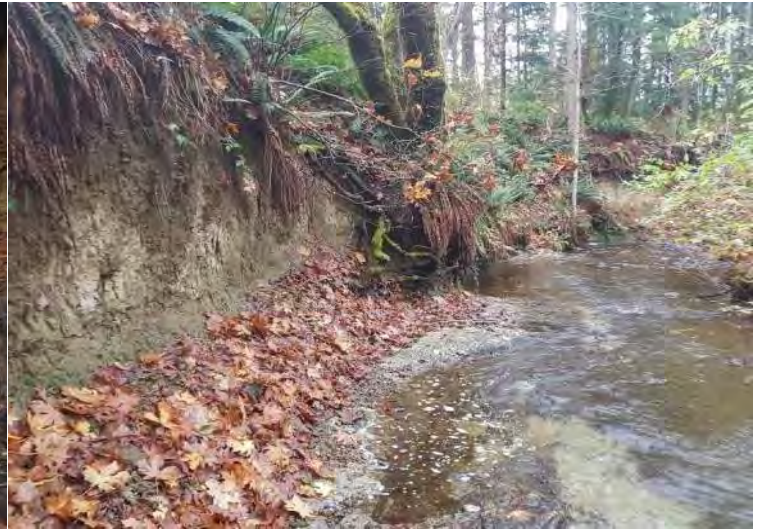
Photo 2, Left bank and channel with exposed stiff clay, erosion and undermining of tree roots visible.

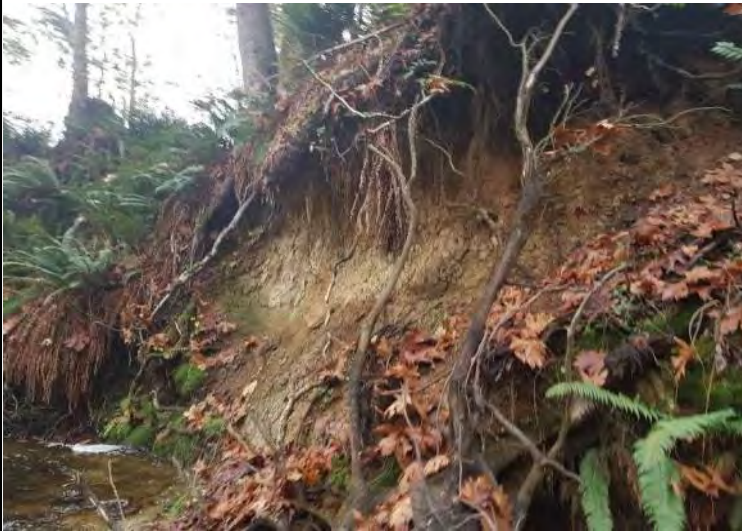
Photo 3, Left bank with undermining of tree roots, stiff clay exposed is visible.

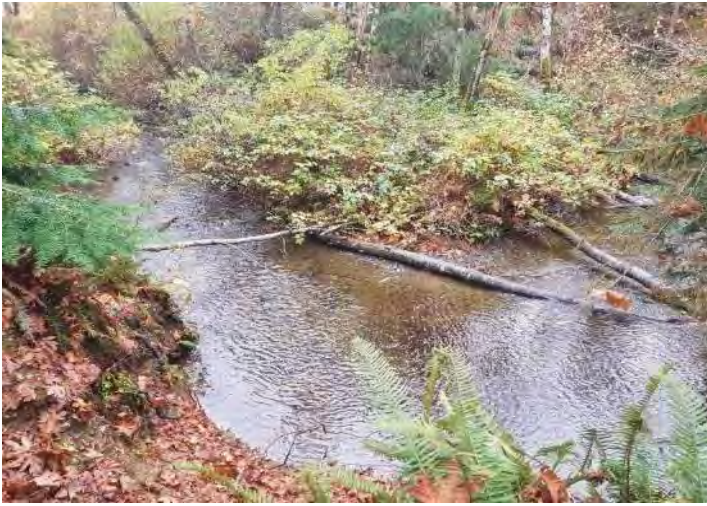
Photo 1, Right bank erosion and bend in creek visible.

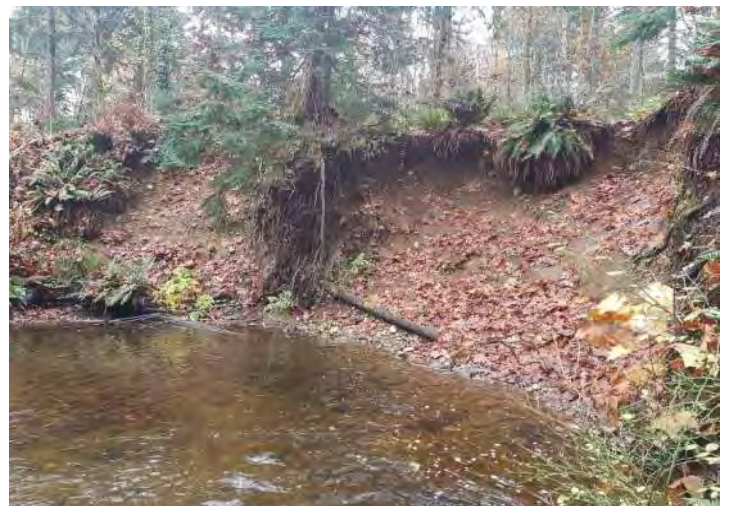
Photo 2, Erosion on right bank, undermined roots visible.

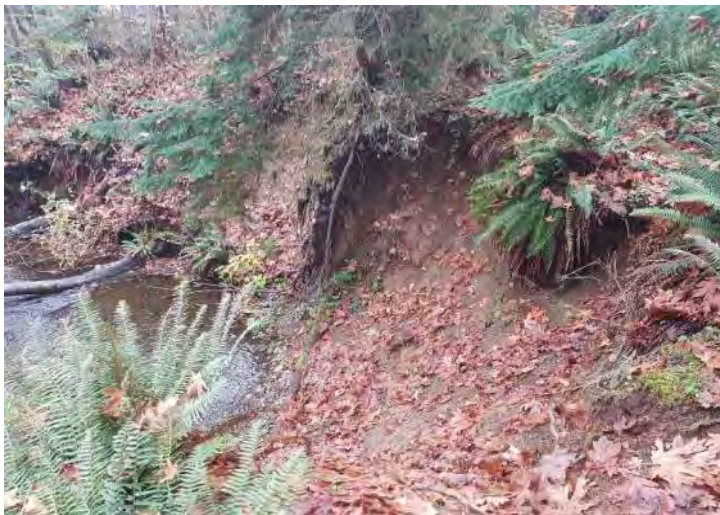
Photo 3, Erosion on right bank, undermined roots visible.

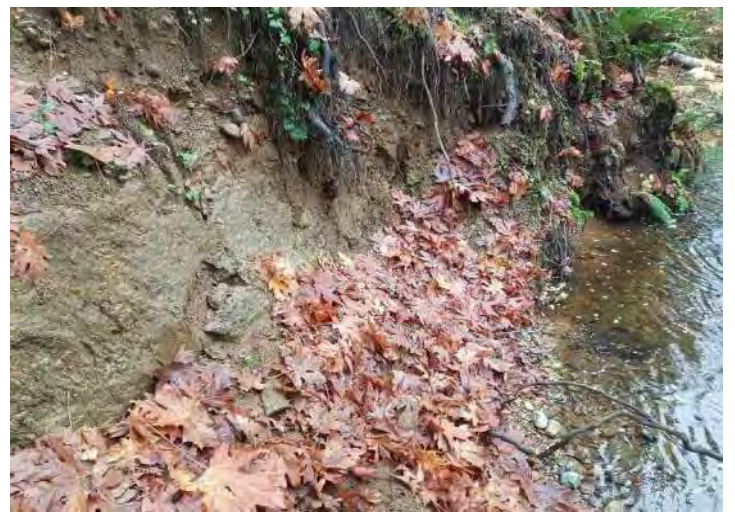
Photo 4, Erosion on right bank.

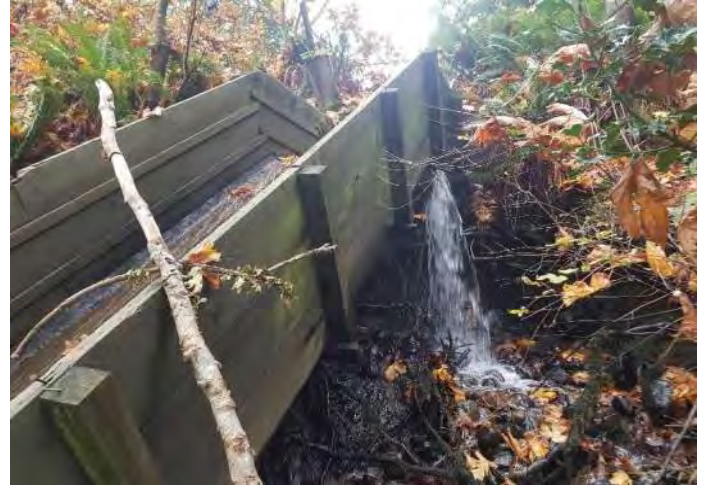
Photo 2, Failure point of timber flume with water leaking onto bank, erosion is visible on the bank.

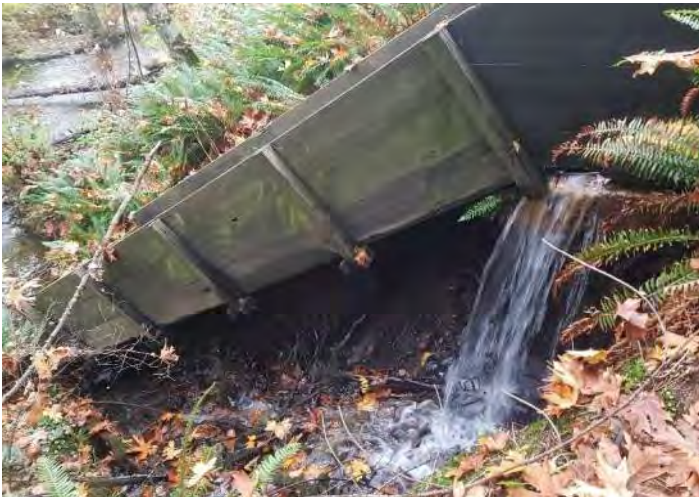
Photo 3, Failure point of timber flume with water leaking onto bank, erosion is visible on the bank.

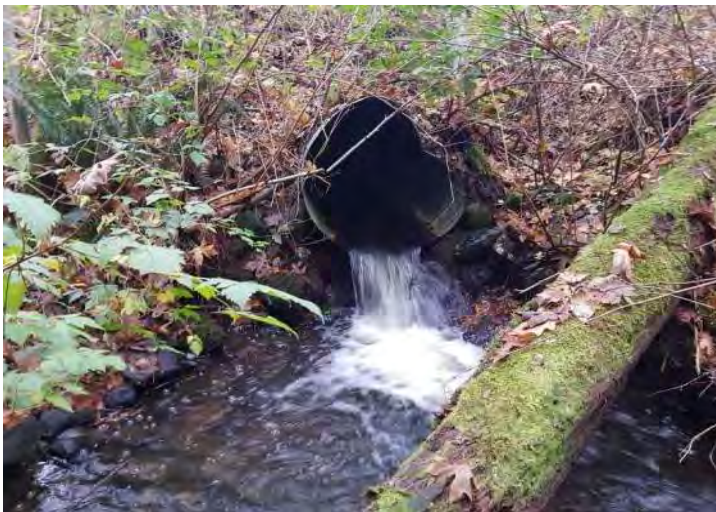
Photo 3, Culvert outlet, mild erosion visible.

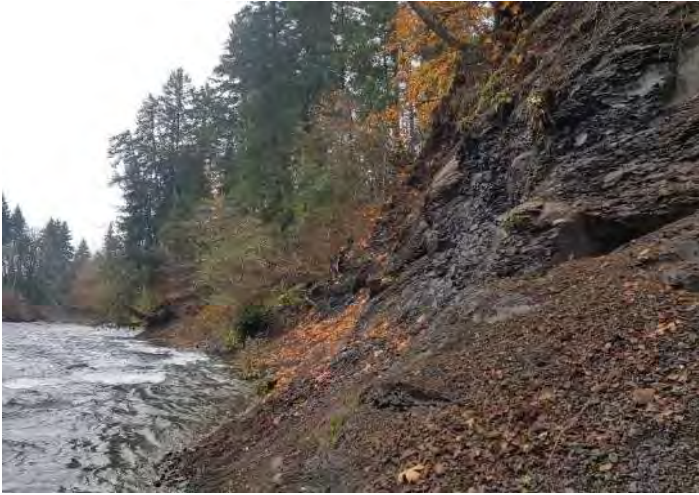
Photo 1, Right bank slope with coluvium apron at base and exposed shale above.

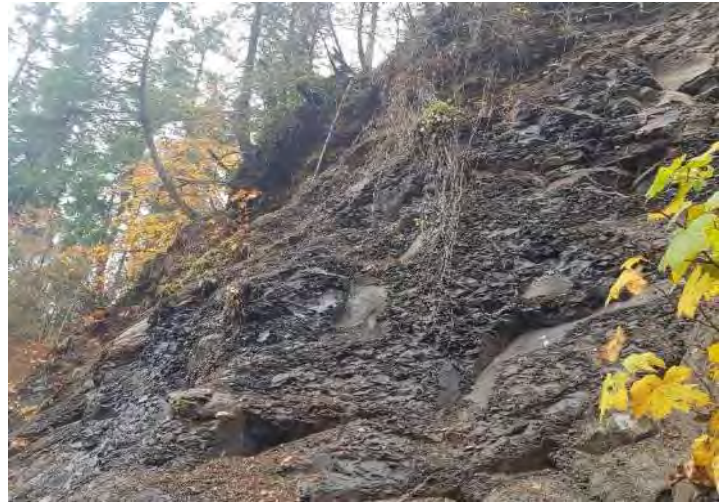
Photo 2, Exposed shale on right bank with overhanging roots and vegetation.

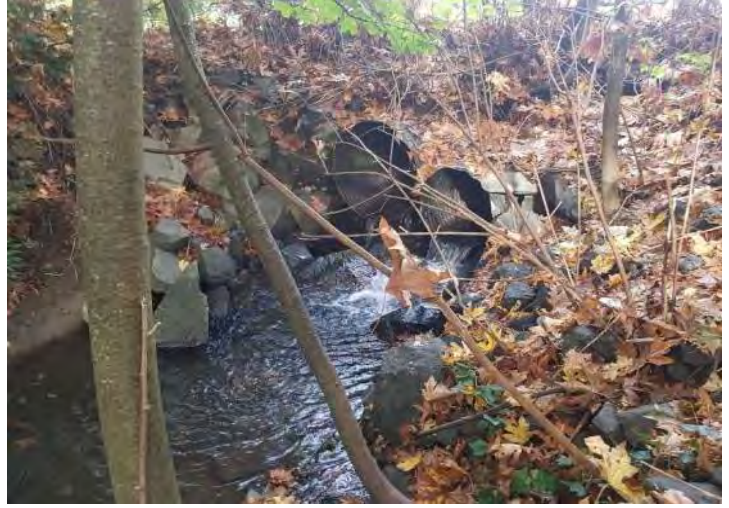
Photo 2, Culvert outlets, erosion visible.

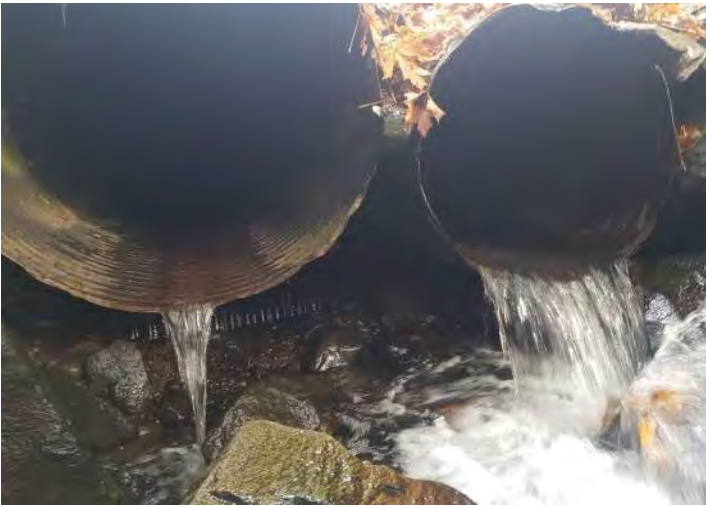
Photo 3, Erosion undermining culvert outlets.

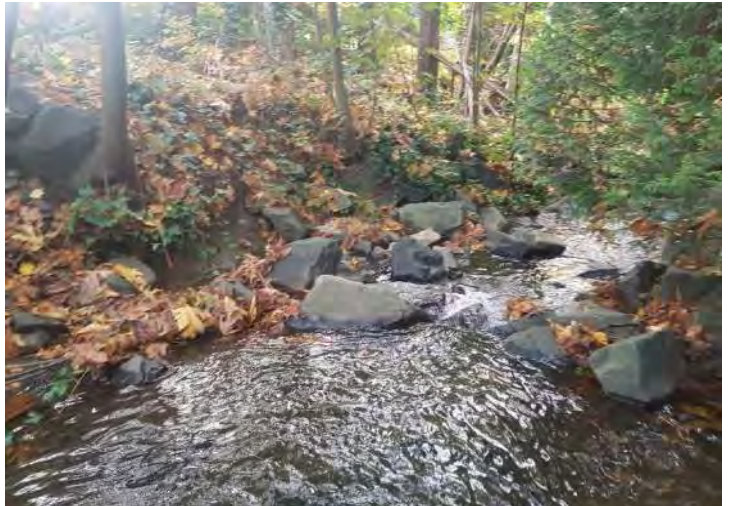
Photo 4, Downstream of culvert outlets, mild erosion on left hand bank visible.

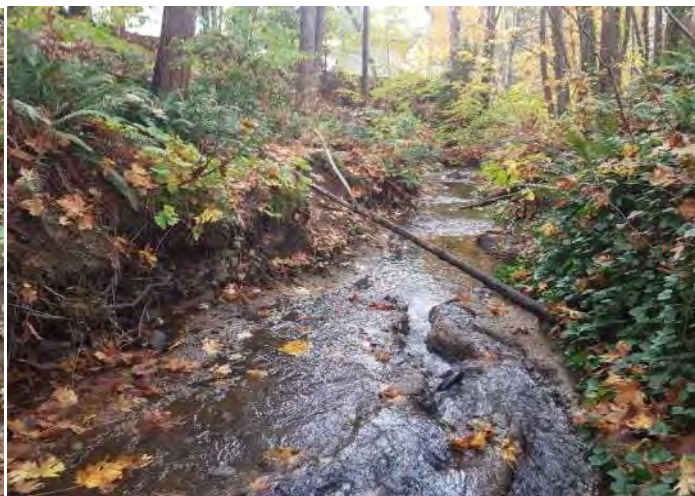
Photo 4, Downstream of culvert outlet, erosion visible on left bank.

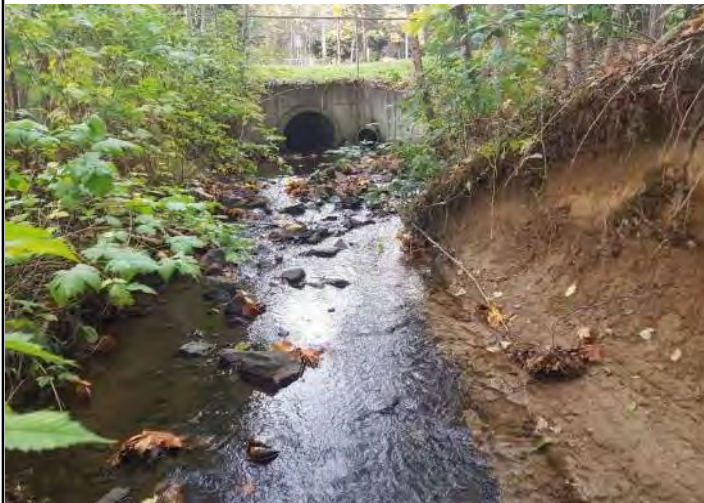
Photo 3, Downstream of culvert, left bank erosion has exposed clay.

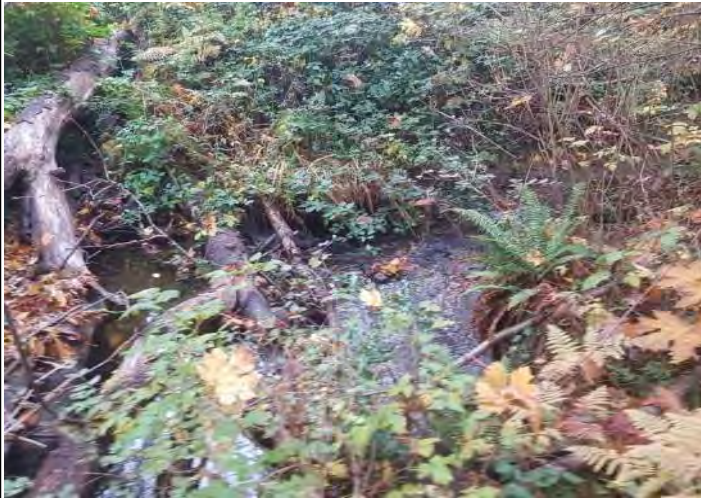
Photo 1, Fallen trees creating dam, sediment bulid up visible.

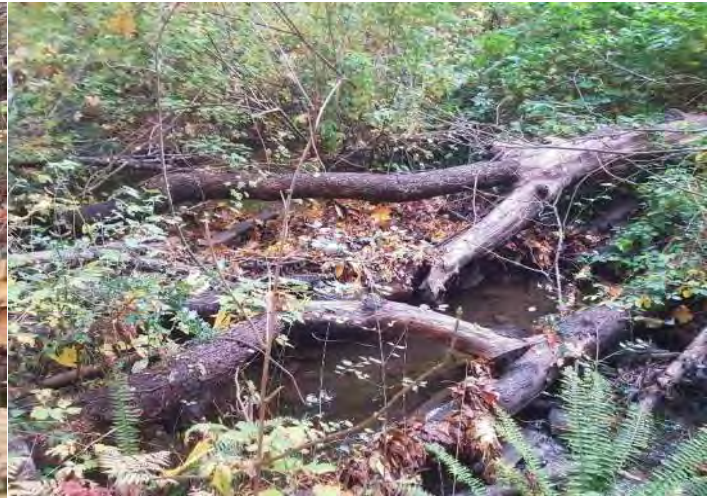
Photo 2, Fallen trees creating dam, sediment bulid up visible.

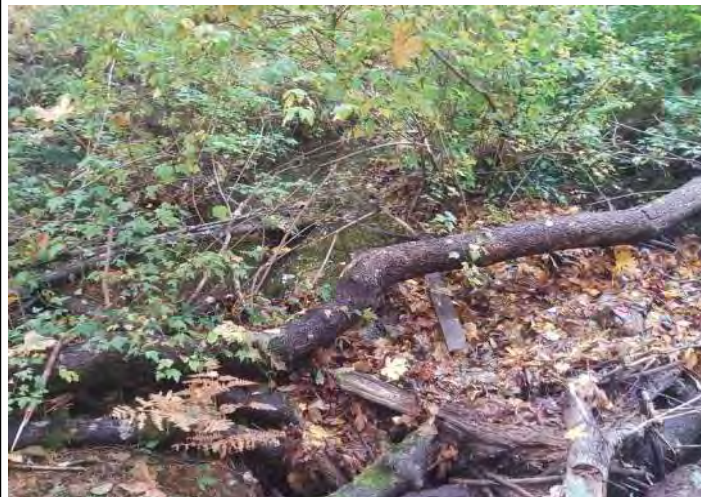
Photo 3, Fallen trees creating dam.

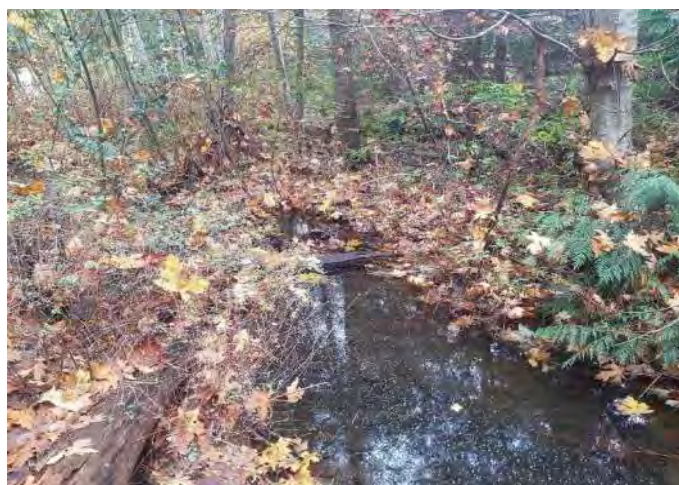
Photo 2, Log jam viewed from upstream, impounded water visible.

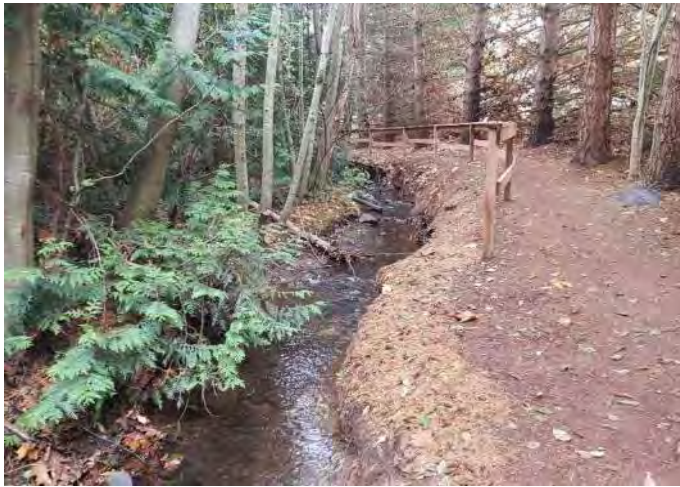
Photo 1, Looking upstream towards failing wall and trail.

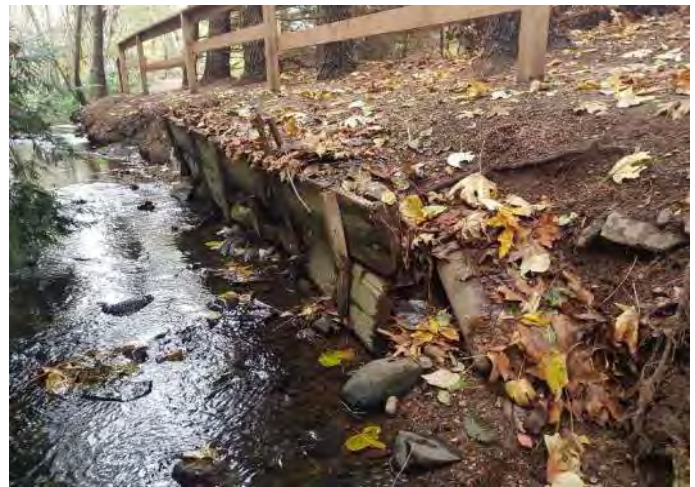
Photo 2, failing wall looking upstream.

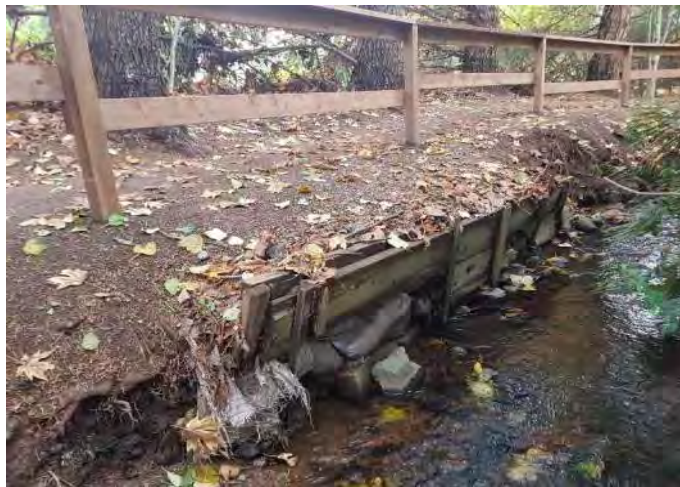
Photo 3, failing wall looking downstream.

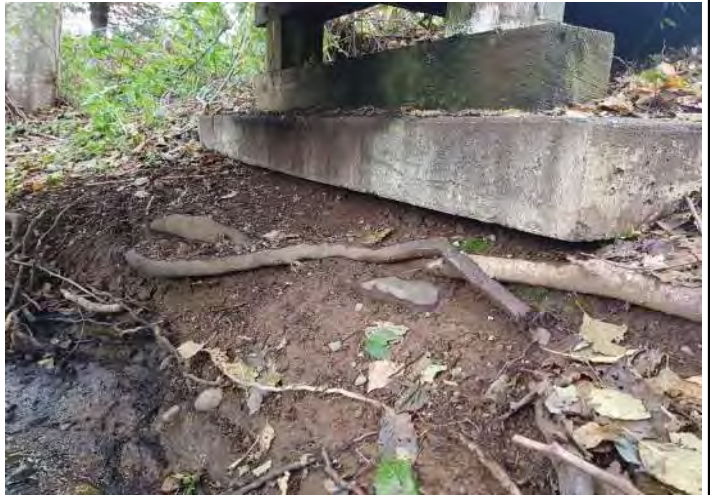
Photo 2, Right bank abutment undermining.
