CITY OF
COURTENAY

November 20, 2019

**RIVER AND STREAM CHANNEL RECONNAISSANCE AND
GEOTECHNICAL STABILITY ASSESSMENT
COURTENAY, B.C.**

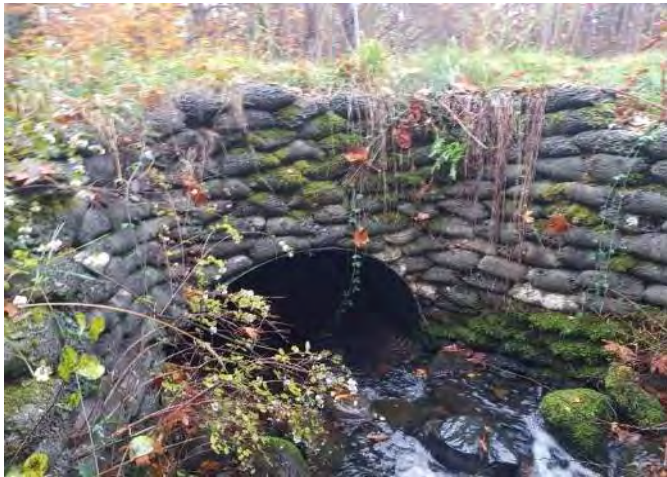
Photo 1, Culvert Inlet, concrete bag wall.

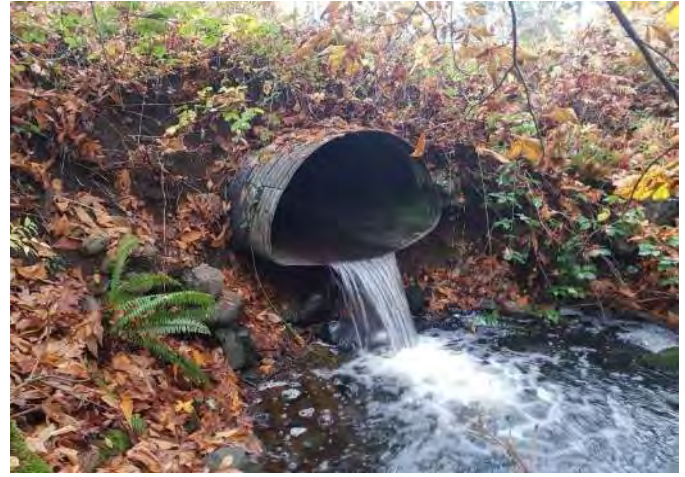
Photo 2, Culvert outlet, erosion of embankment and undermining of culvert visible.

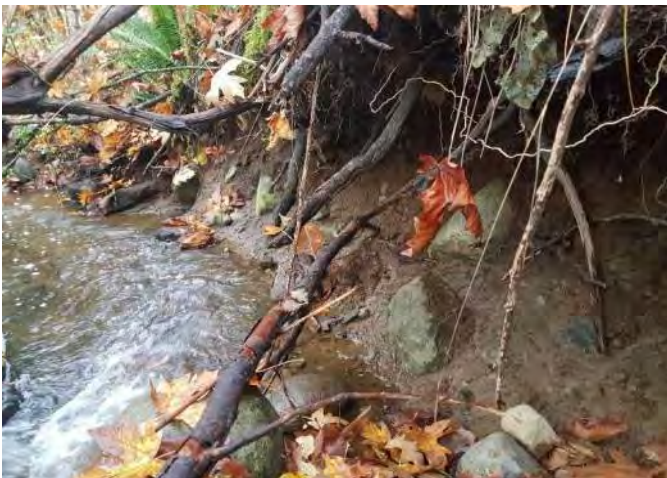
Photo 3, Erosion of right bank downstream of culvert.

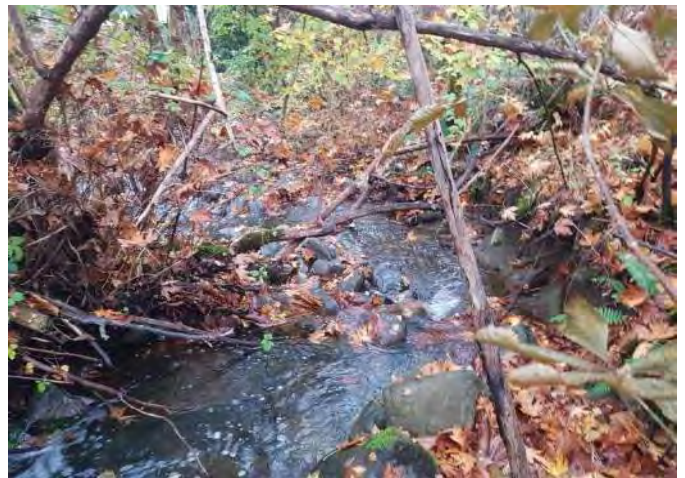
Photo 4, Downstream of culvert outlet.

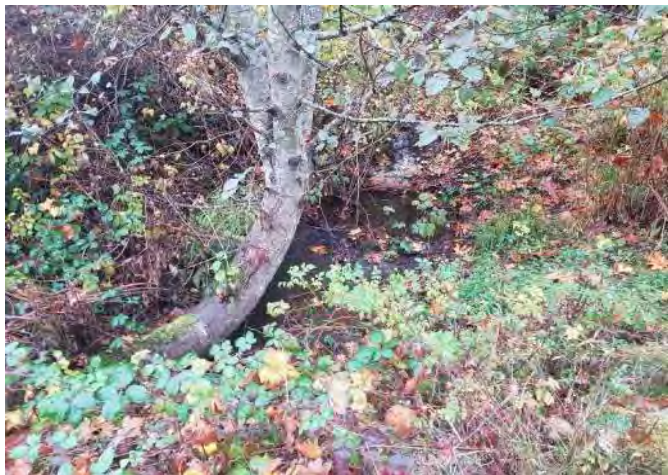
Photo 1, Upstream channel.

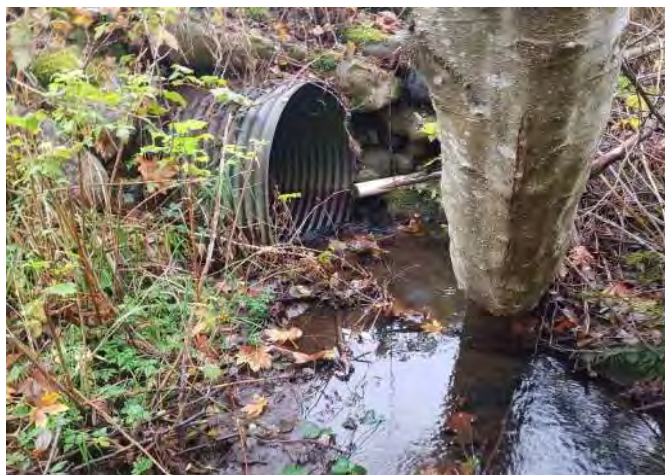
Photo 2, Culvert inlet, PVC outlet visible.

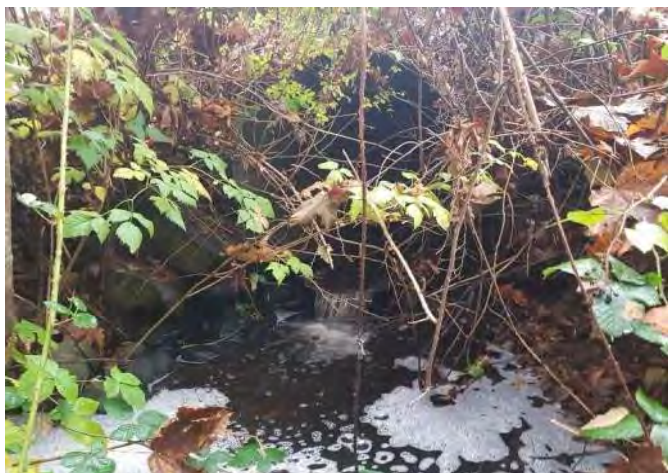
Photo 3, Culvert outlet, drop in channel visible.

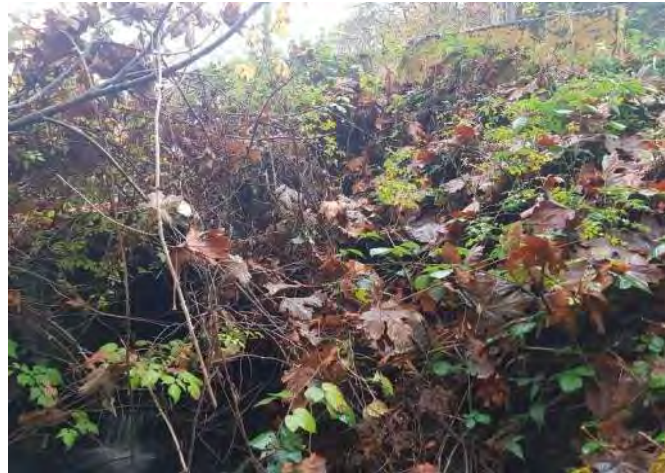
Photo 4, Culvert outlet headwall, erosion visible beneath vegetation, barriers visible at crest of bank.

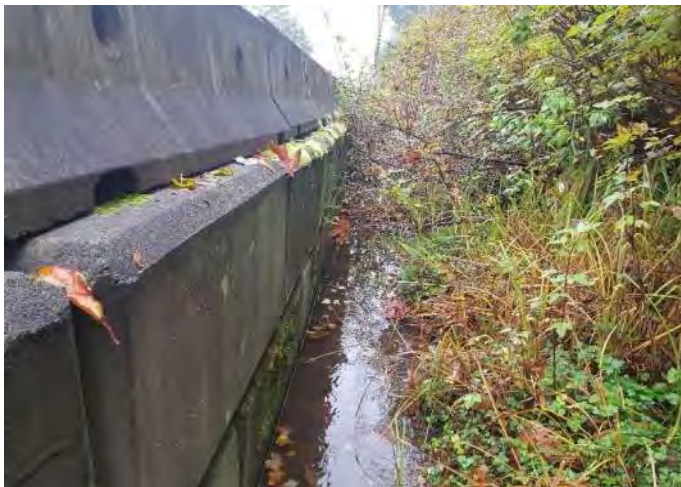
Photo 3, left bank lock block and creek channel.

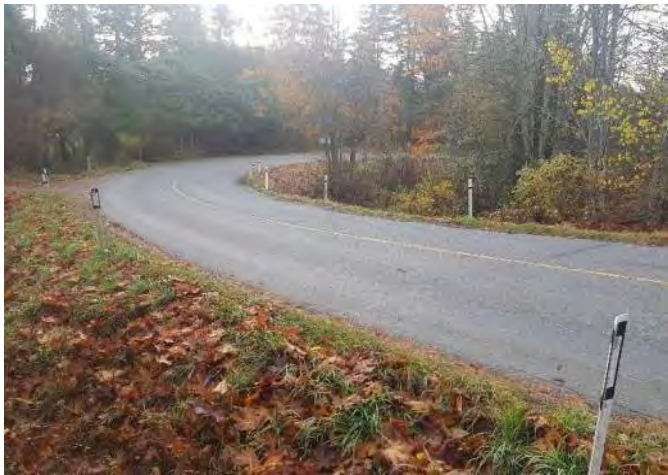
Photo 1, Hairpin Corner on Back Road

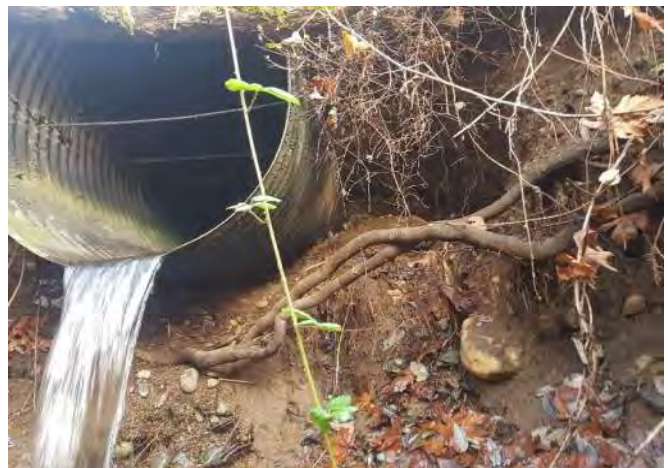
Photo 2, Erosion around culvert outlet, undermining culvert and embankment.

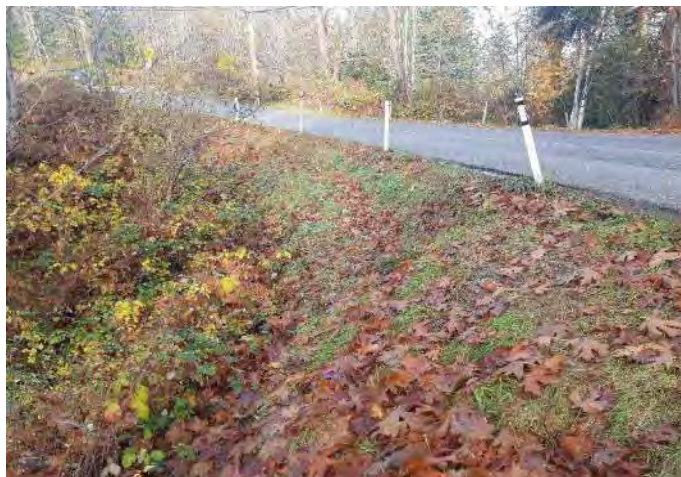
Photo 3, Embankment slope above culvert outlet.

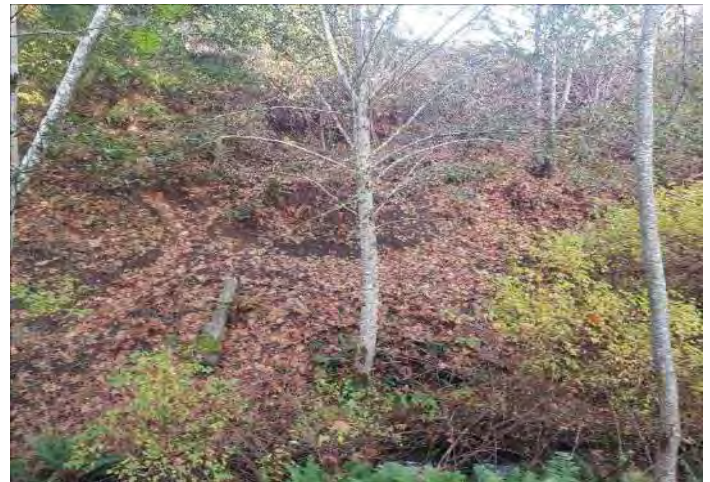
Photo 4, Looking across at erosion on right slope. Downstream of culvert outlet.

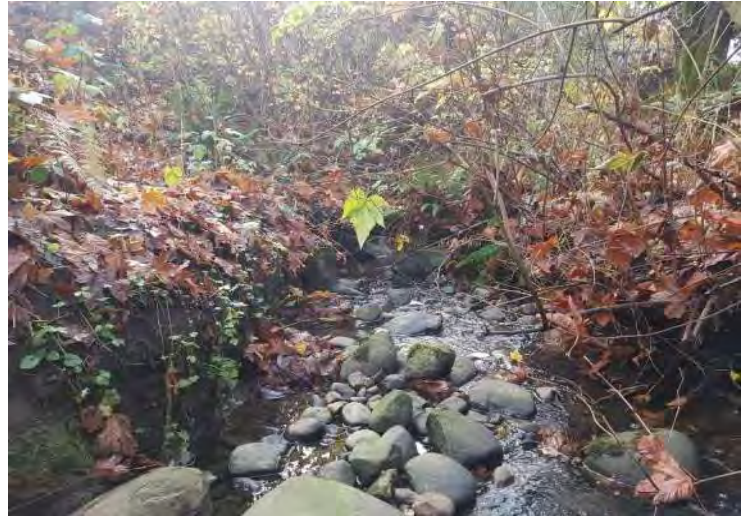
Photo 6, looking downstream from culvert outlet.

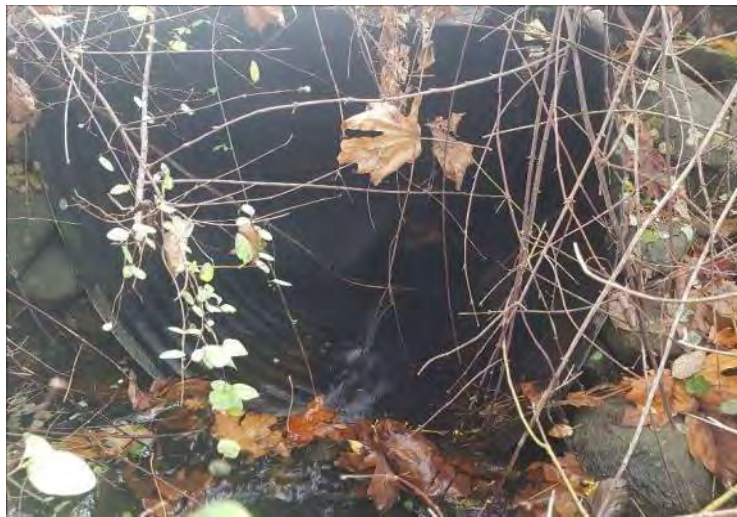
Photo 7, Culvert inlet.

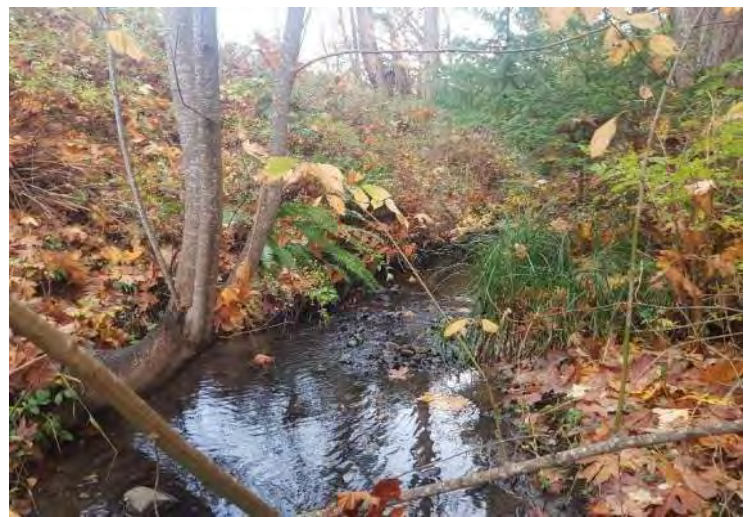
Photo 8, looking upstream from culvert inlet.

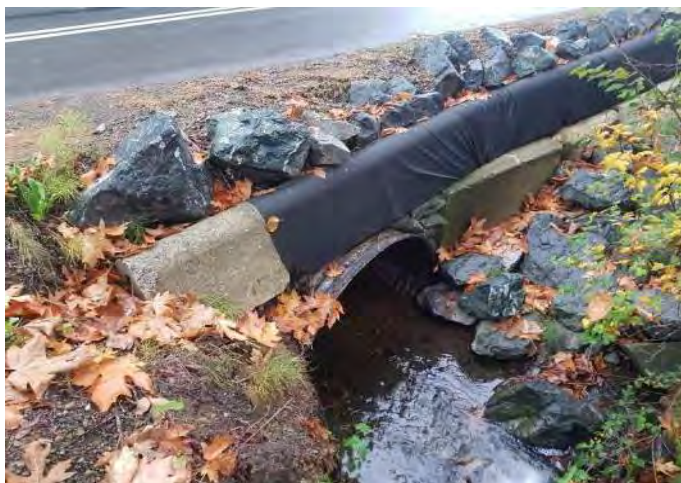
Photo 2, Culvert inlet and headwall.

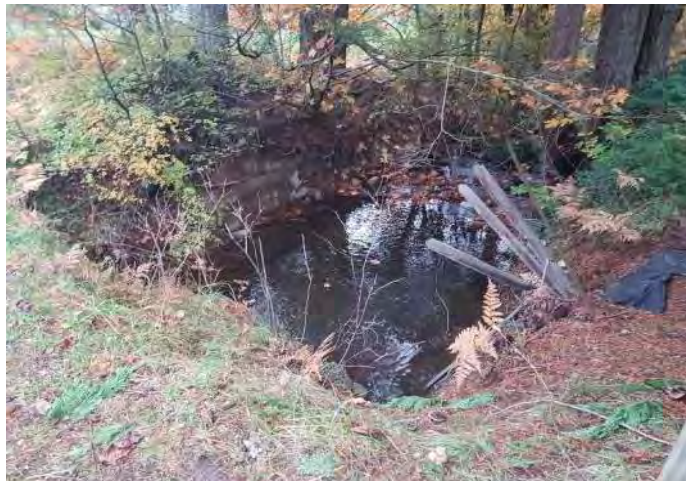
Photo 4, Channel looking downstream from culvert

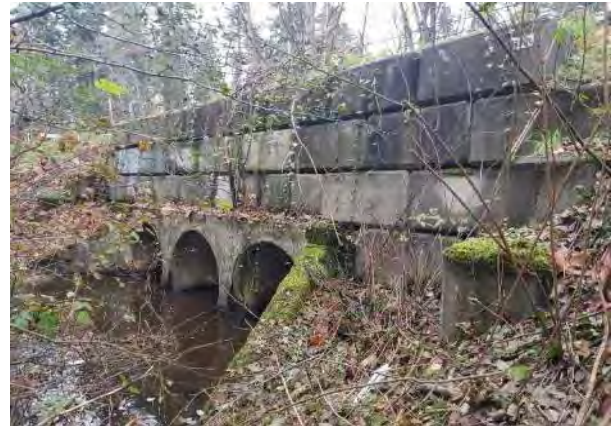
Photo 2, Upstream of culvert, serial number visible.

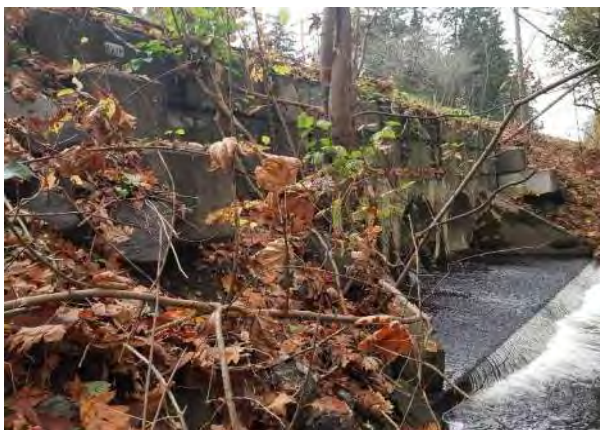
Photo 3, Downstream of culvert, undermining of left and right bank lock block walls visible.

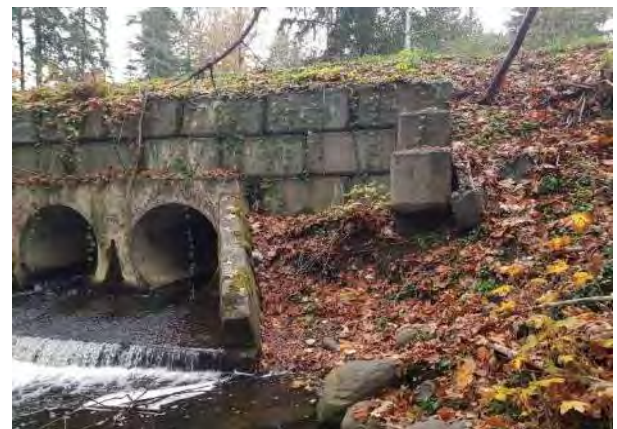
Photo 4, Severe undermining of left bank lock block wall visible. Outlet structure.

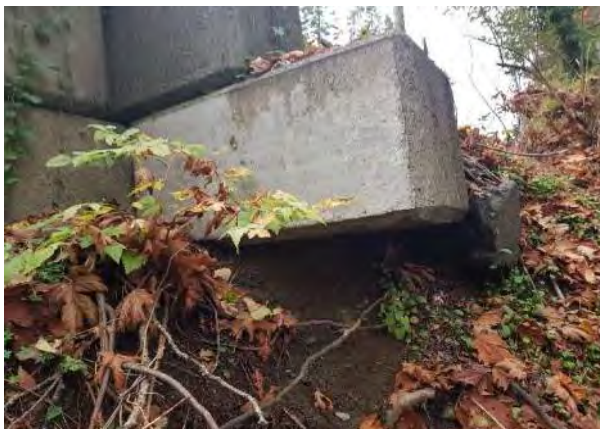
Photo 5. Undermined lock block on left bank at outlet structure.

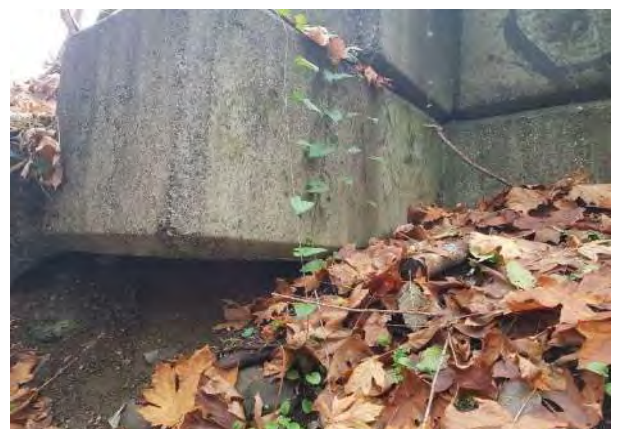
Photo 6. Undermined lock block on right bank at outlet structure.

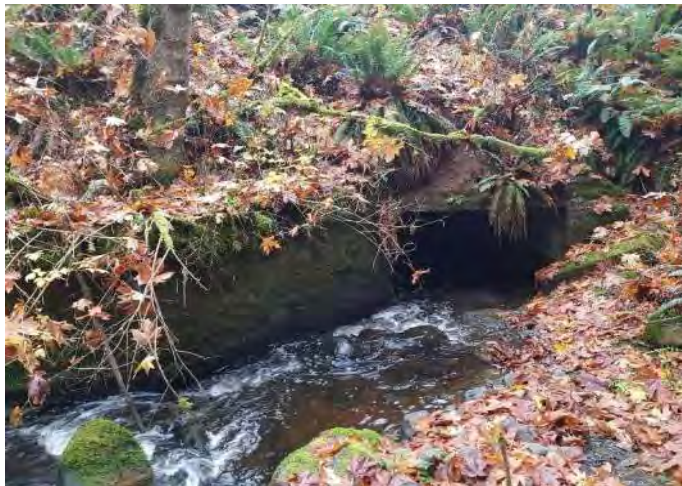
Photo 3, Upstream culvert inlet.

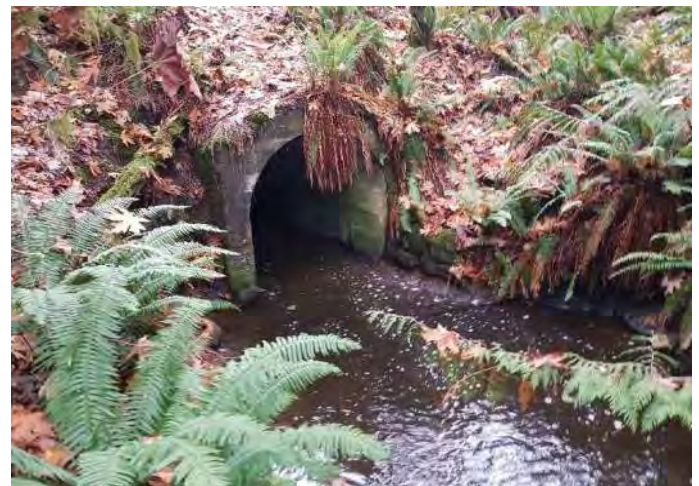
Photo 4, Downstream culvert outlet.

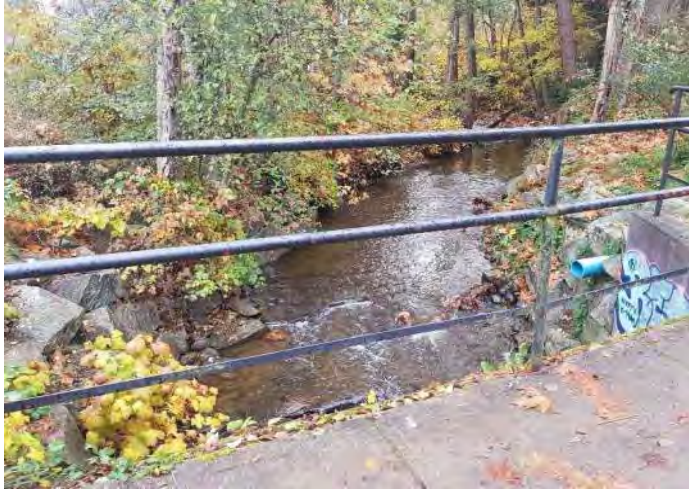
Photo1, Upstream channel.

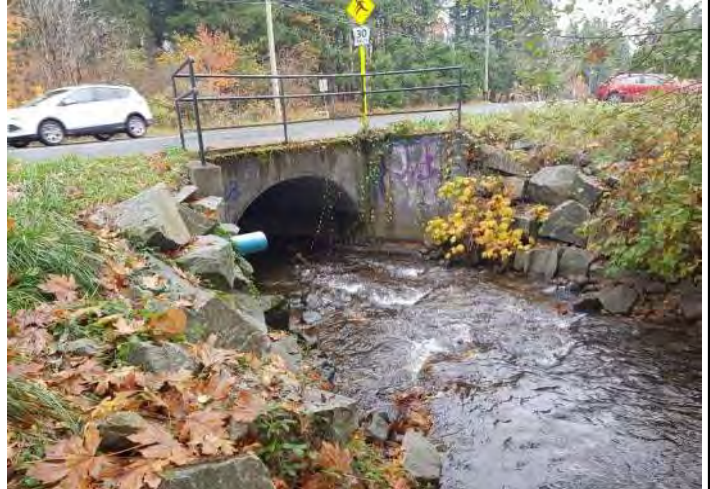
Photo 2, Culvert inlet.

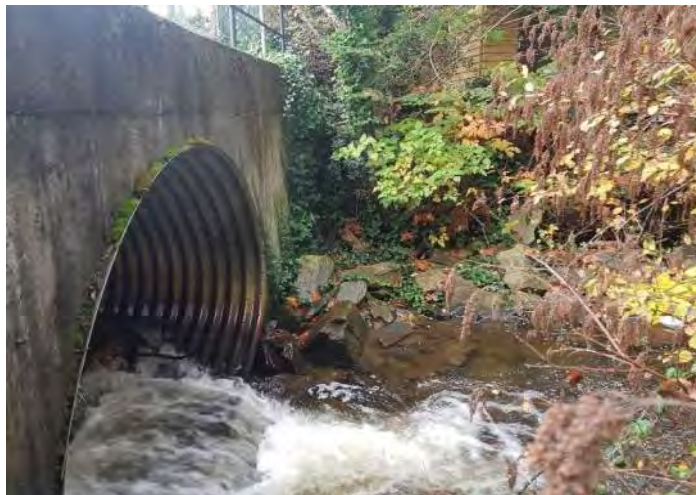
Photo 3, Outlet of culvert and left bank.

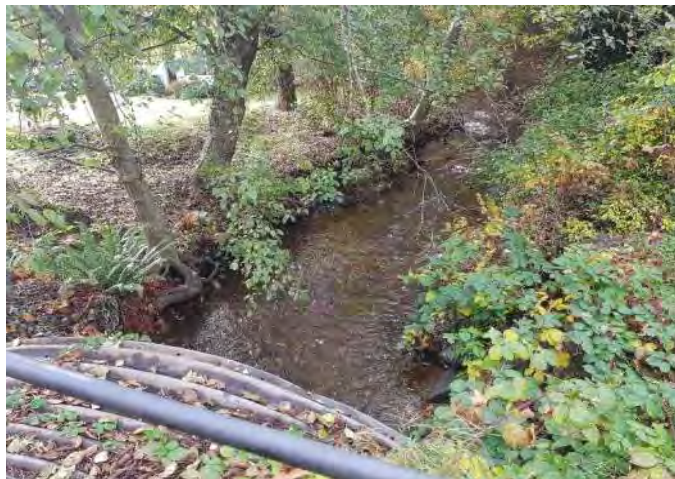
Photo 1, Upstream channel.

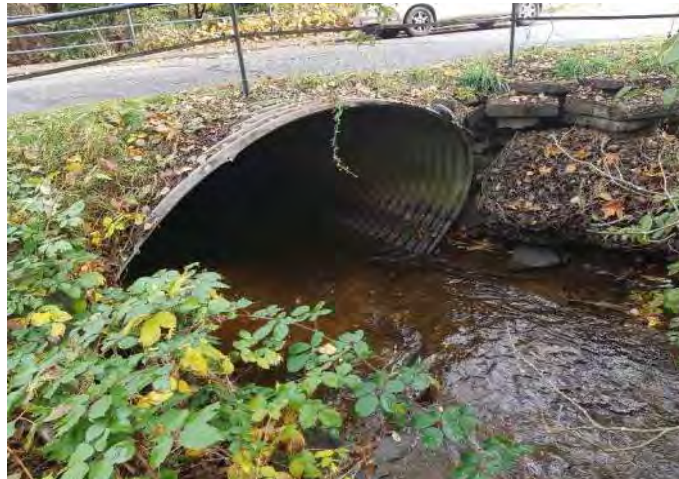
Photo 2, Upstream of culvert, undermining and rotation of gabion basket visible on right bank.

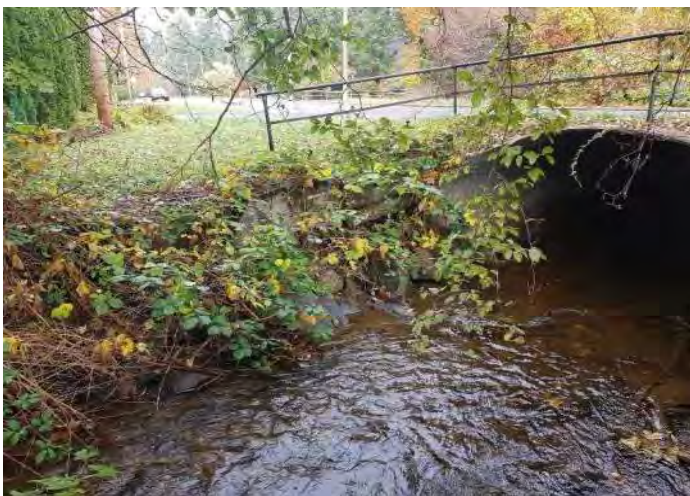
Photo 4, Upstream of culvert left bank with riprap and lock block protection (behind vegetation).

Erosion undermining roots of trees at the crest of the bank, see photos 3 and 4 and schematic section below.

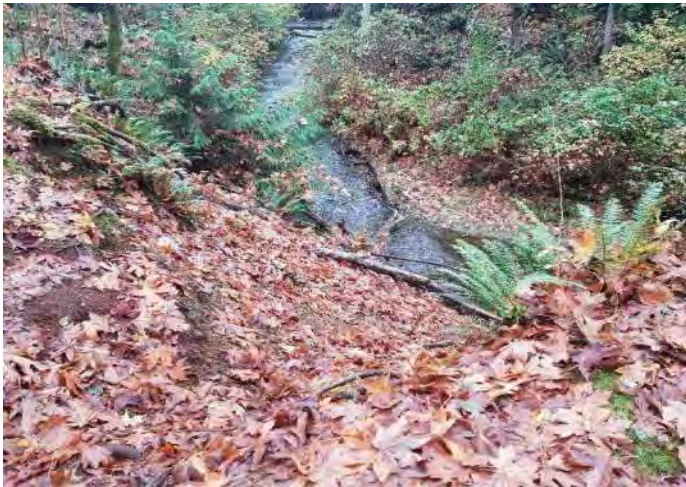
At the upstream end of the reach the crest of the bank has collapsed, likely where a tree has overturned. This appears to have forced the relocation of the park path at the crest to increase setback. See photo 2.

Photo 1, Looking down at right bank erosion where crest collapsed.

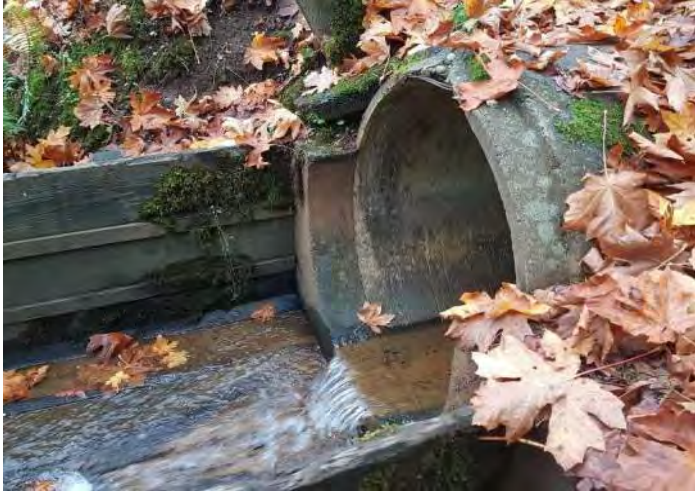
Photo 1, Concrete stormwater pipe flowing into timber flume.

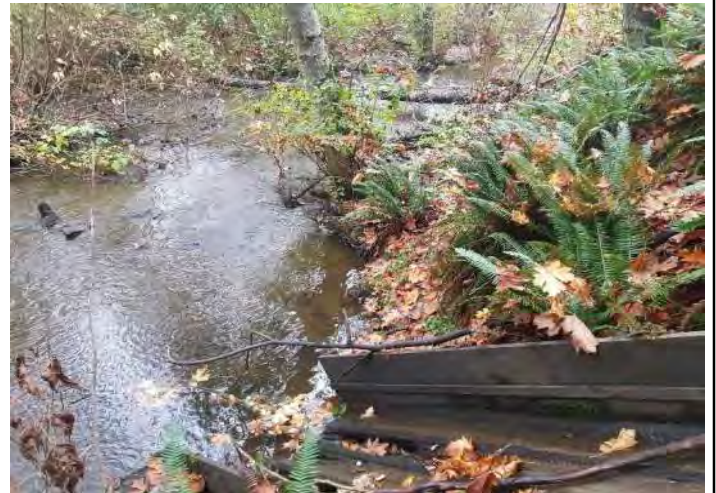
Photo 4, Flume exiting into the creek at toe of bank.

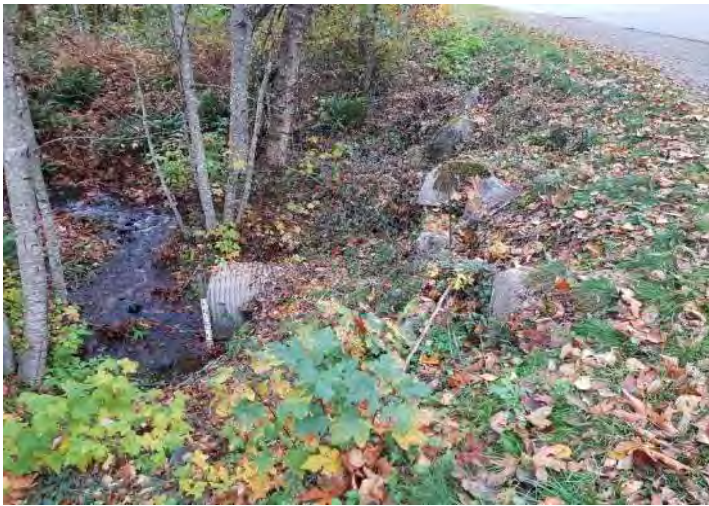
No significant erosion is evident upstream of the culvert, good condition. See photo 1.

Photo 1, Upstream of culvert and culvert inlet.

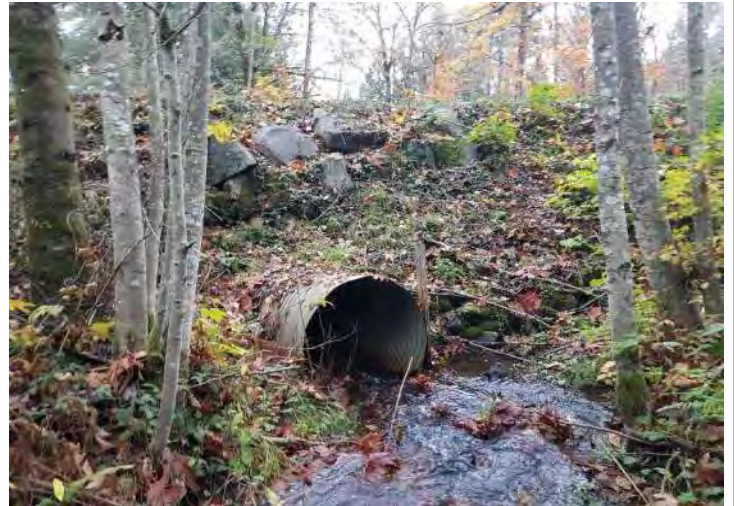
Photo 2, Culvert inlet, dry stack boulder armouring visible on embankment slope.

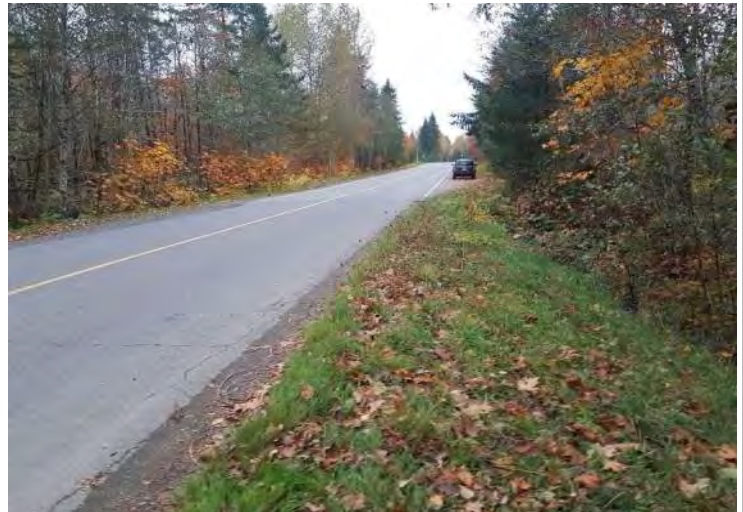
Photo 4, Grassy sloping shoulder leading to downstream embankment slope.

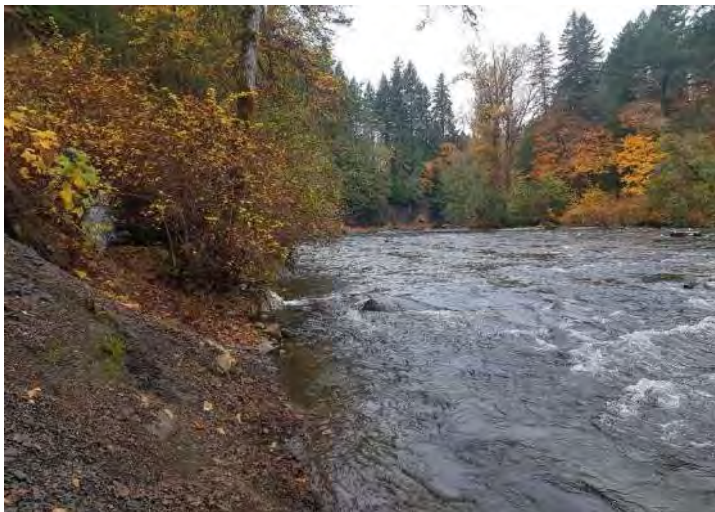
Exposed shale bedrock on bank extending up to crest and in channel bed. See photos 1, 2 and 3.

Photo 3, River channel looking upstream.

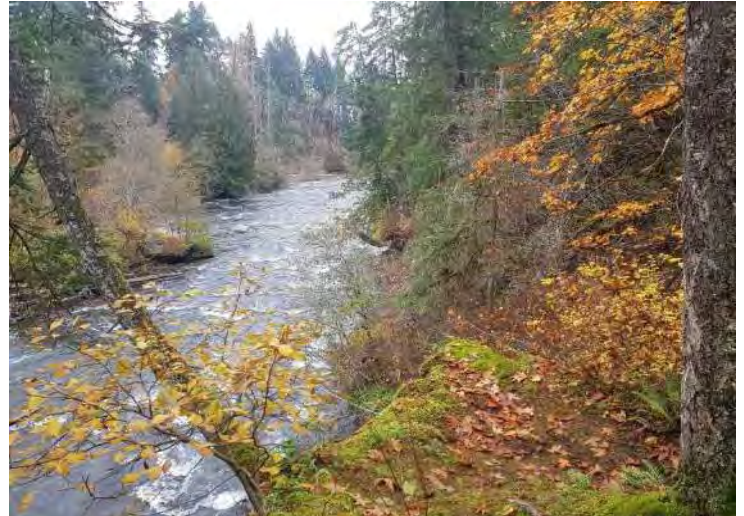
Photo 4, Looking downstream from crest of lower slope.

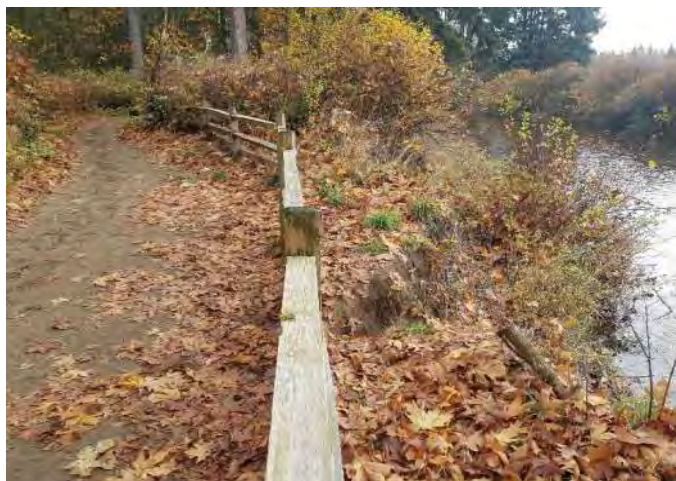
If erosion continues it may damage the fence and footpath. Potential for personal injury if pedestrian does not see the damage to path.

Photo 1, Public footpath and left bank of river, erosion visible.

Redirect path locally to increase set back from natural erosion process.
Erosion could potentially be repaired/mitigated with the installation of riprap.
Erosion should be monitored with the risk managed appropriately.

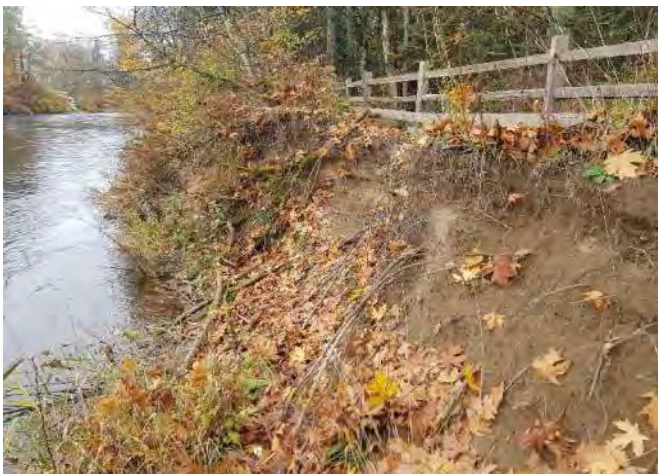
Photo 2, Left bank erosion.

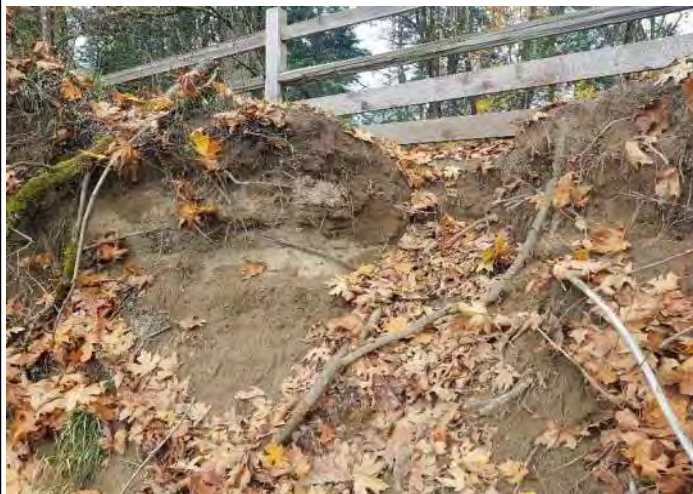
Photo 3, Left bank erosion.

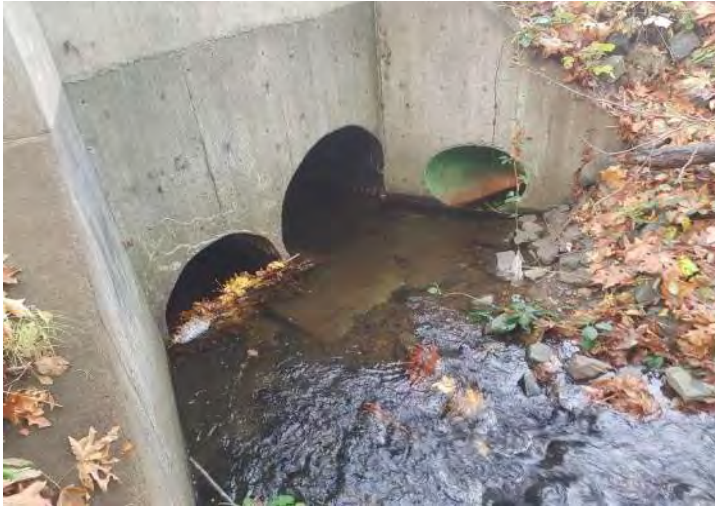
Upstream of inlet, channel is in good condition - no erosion, gully approximately 2m deep with recent 150mm to 300mm diameter riprap armoring edges of headwall.

Photo 1, Concrete headwall at inlet.

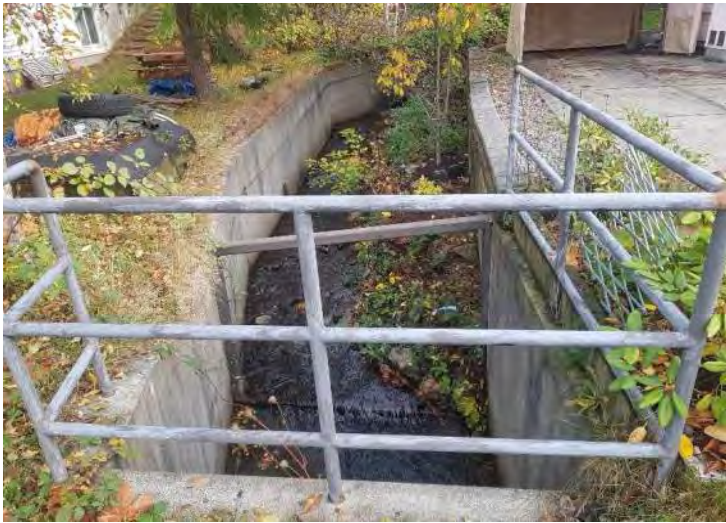
Photo 1, up stream of culvert, concrete walls and bracing visible.

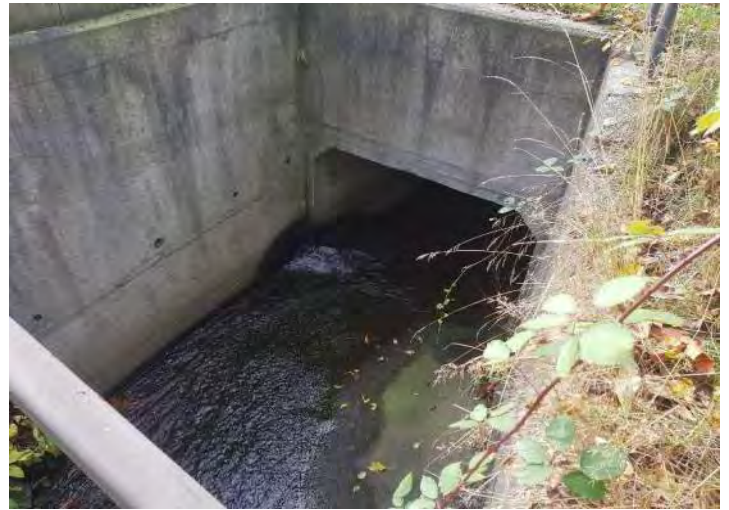
Photo 2, Inlet of box culvert.

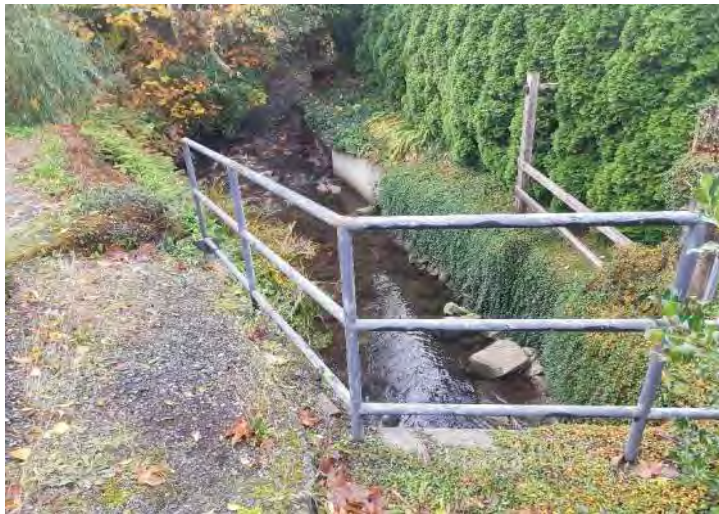
Degradation of private timber walls downstream of culvert could result in increased sediment/turbidity or wood debris.

Photo 3, Outlet of culvert, and private retaining walls further downstream.

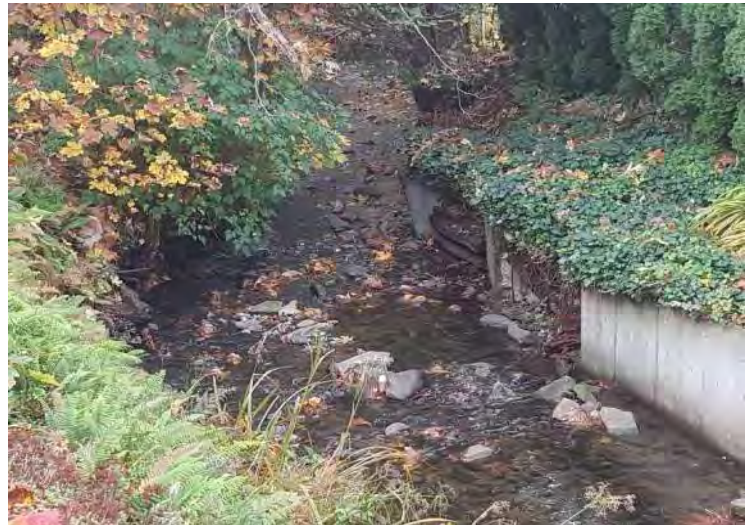
Slow progress as wood degrades and retained soil erodes.

Photo 4, Private timber retaining walls on left bank.

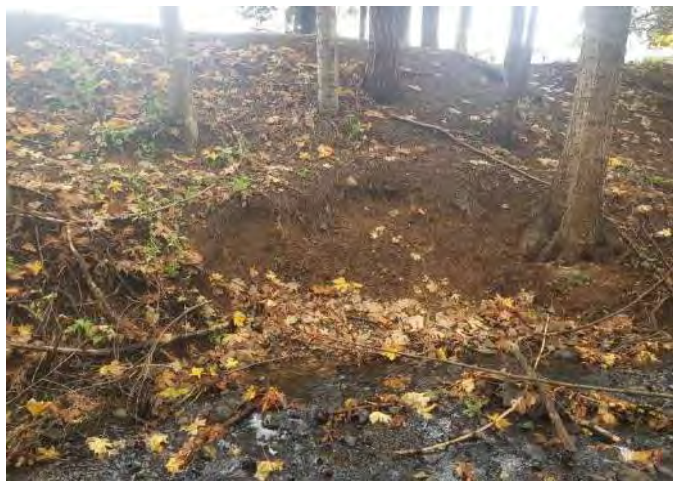
Photo 1, Mild erosion on right bank upstream of culvert.

Repair erosion of embankment and toe with rockfill or soil bag retaining wall or similar.

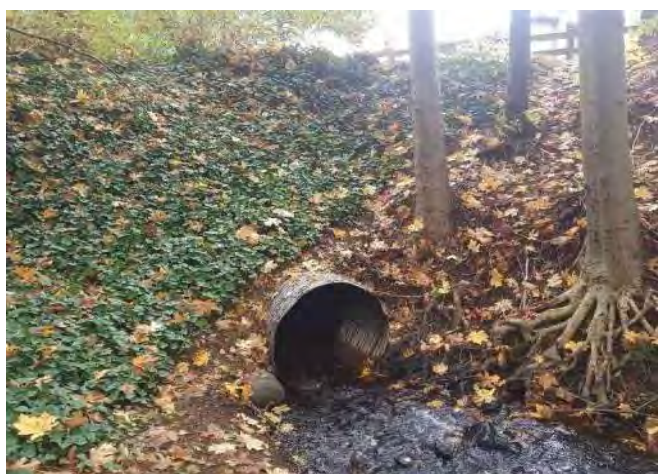
Photo 2, inlet of culvert.

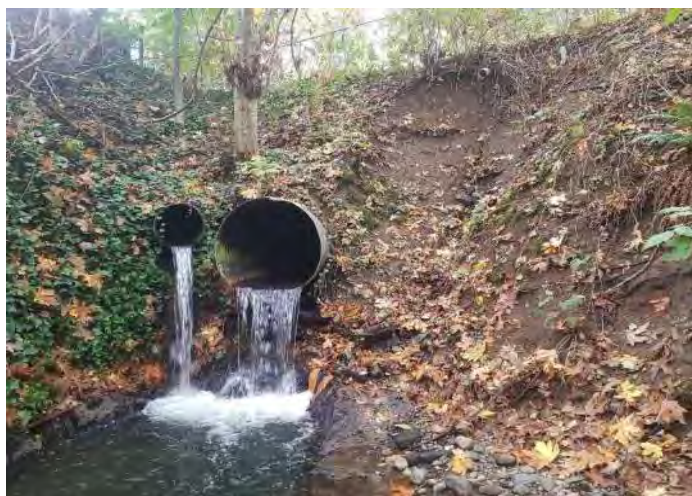
Photo 3, Outlet of culvert, storm and PVC pipe, Erosion visible below culvert outlet and pvc outlet near crest of slope.

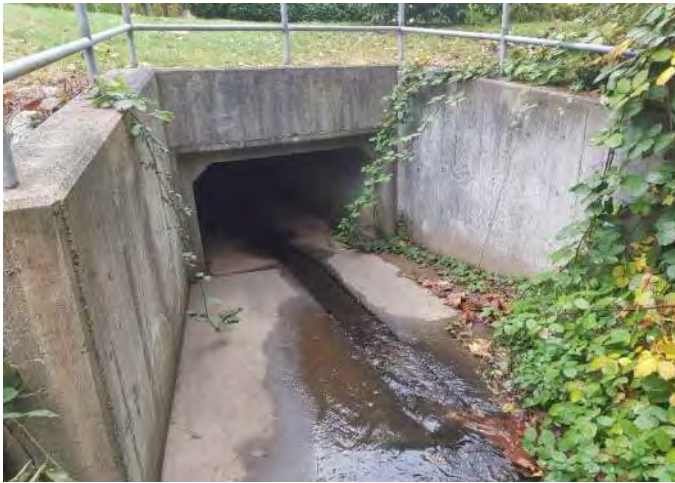
In good condition, relatively new concrete structure, see photo 1.

Photo 1, Inlet of Culvert.

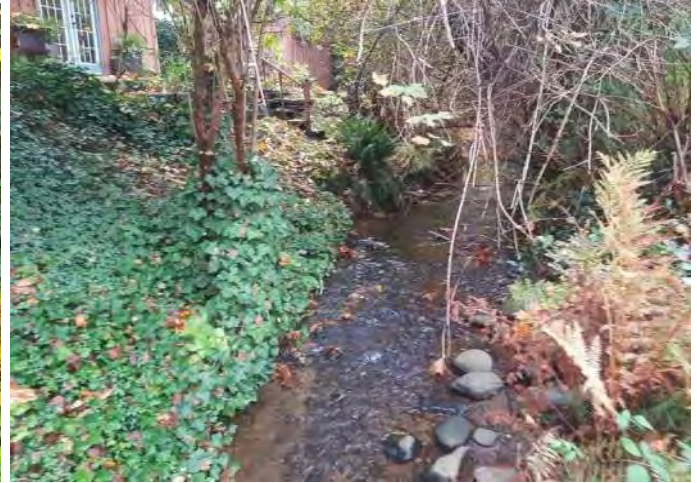
Photo 2, Upstream of culvert inlet, channel base visible.

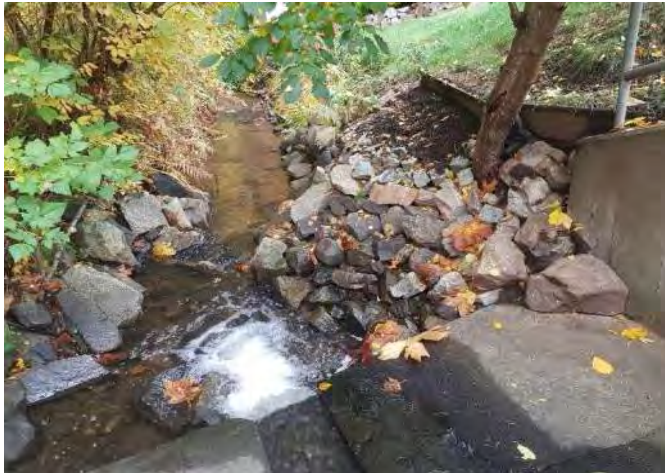
Photo 3, Downstream of Culvert outlet, riprap and channel base visible.

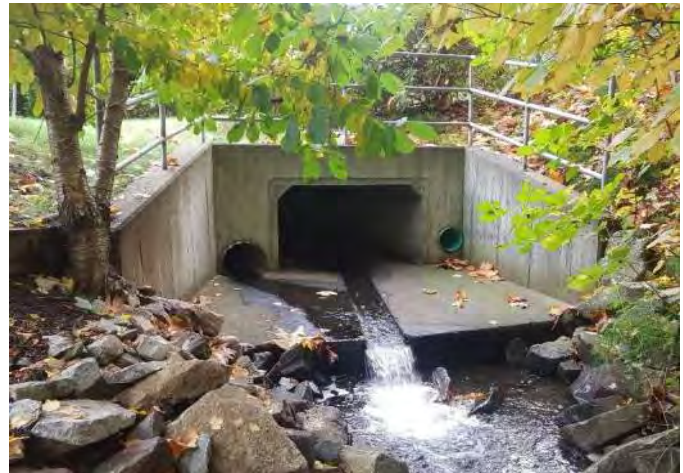
Outlet in good condition, relatively new concrete structure with 150mm to 300mm diameter riprap protecting banks.

Photo 4, Outlet of Culvert and other pipes, riprap bank protection is visible.

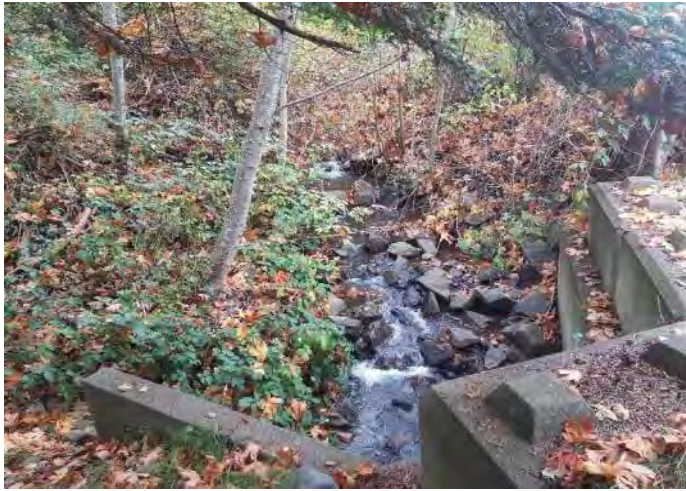
Good condition, channel lined with riprap, 150mm to 450mm diameter. See photo 1.

Photo 1, Upstream of culvert with riprap and concrete block wall visible.

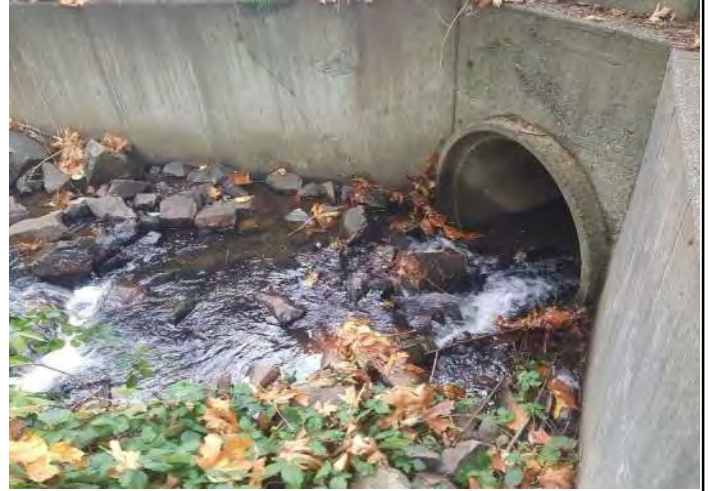
Photo 2, Inlet of culvert.

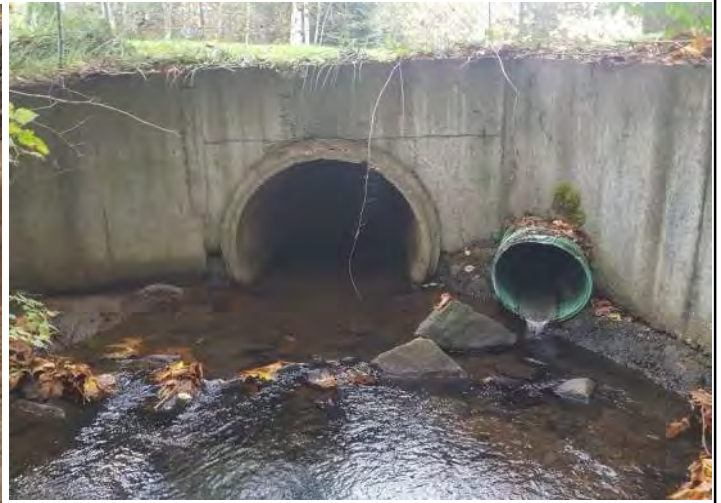
Good condition, no significant erosion at culvert outlet.

Photo 4, outlets of culvert and storm drainage.

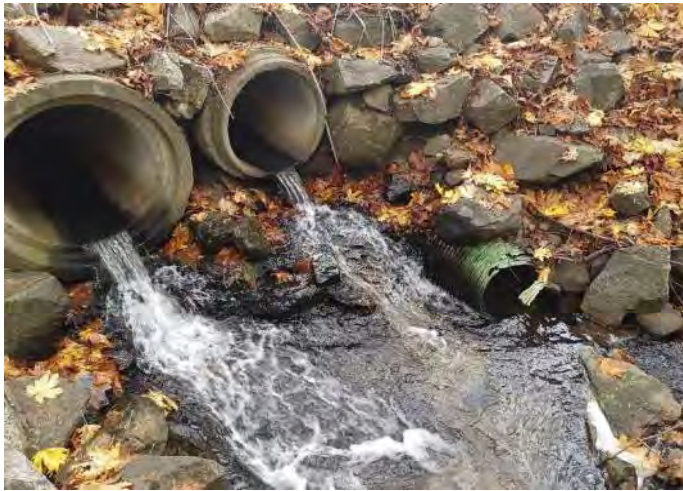
Photo 1, Culvert outlets and storm outlet, mild erosion visible.

Monitor and repair erosion as needed.

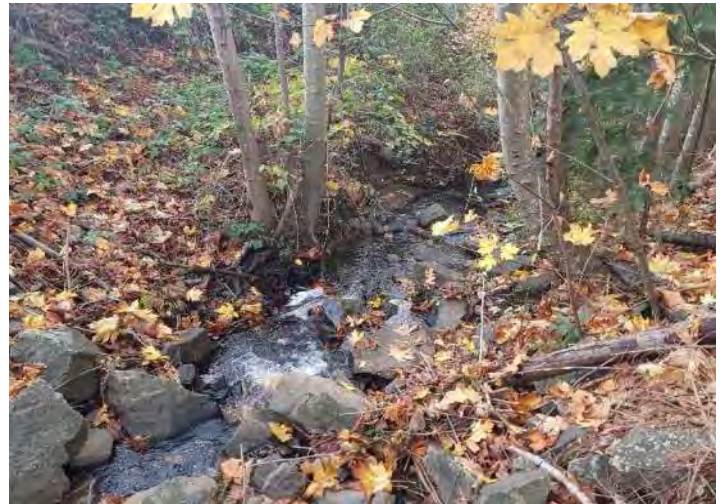
Photo 2, Downstream of outlet, riprap visible.

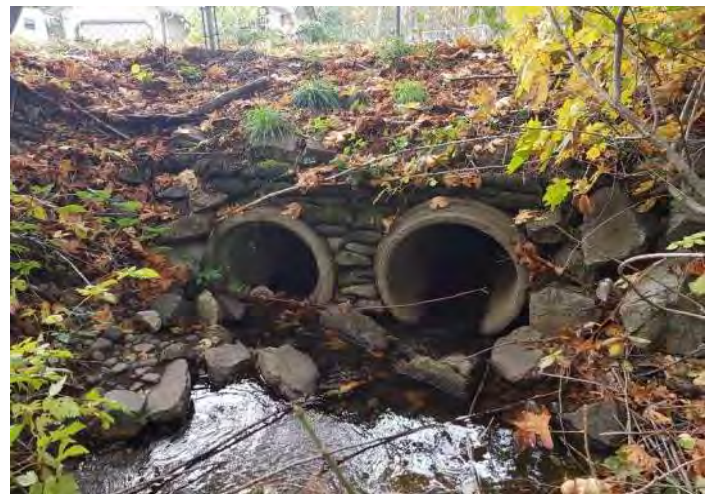
Riprap and concrete sack wall as culvert headwall, in good condition. See photos 3 and 4.

Photo 4, Culvert inlets, concrete bag wall and riprap visible.

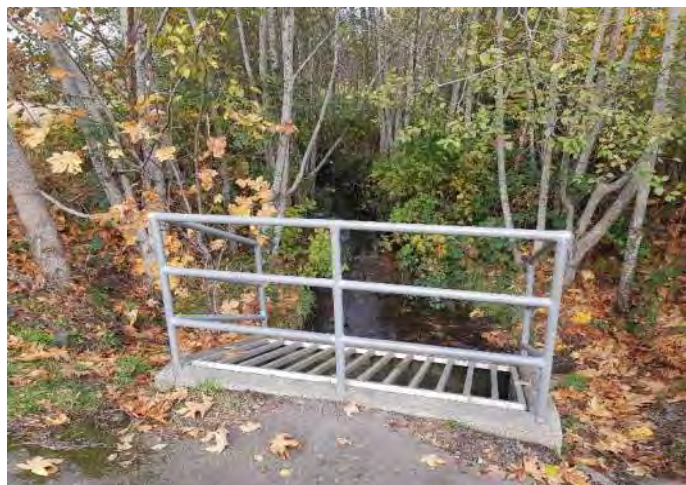
Photo 1, Upstream channel and culvert.

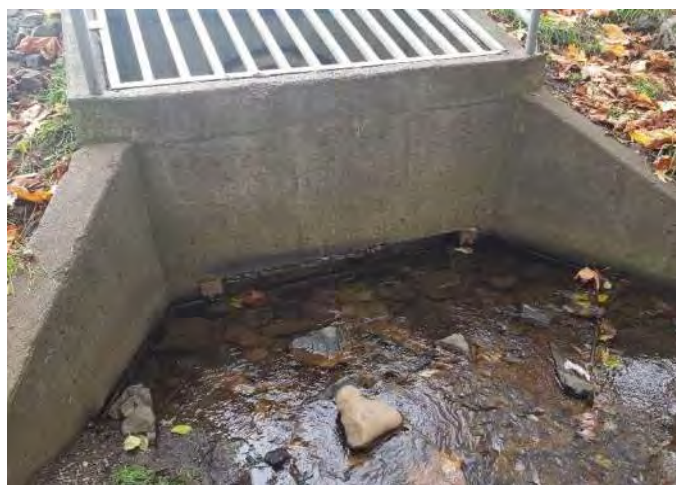
Inlet is concrete headwall structure with debris rack, clear and good condition.

Photo 2, Culvert inlet.

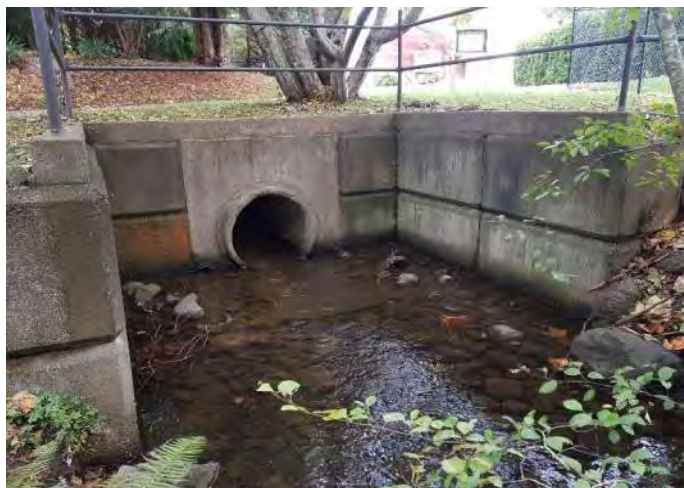
Outlet is lock block wall, 1.5m High - no erosion and good condition.

Photo 3, Culvert outlet.

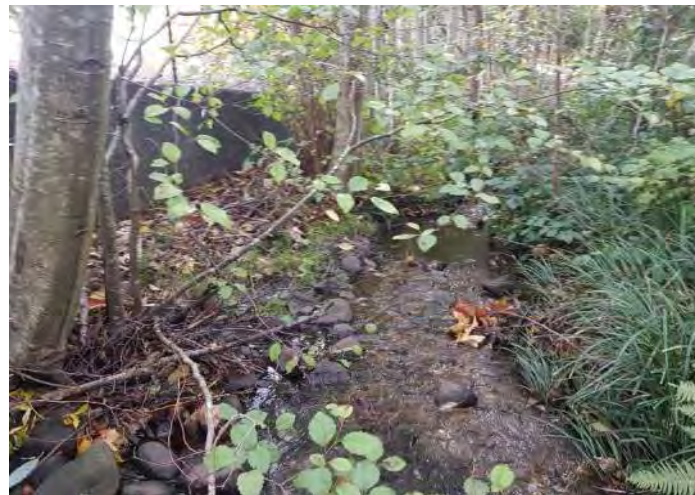
Photo 4, Downstream of culvert outlet.
