CITY OF
COURTENAY

November 20, 2019

**RIVER AND STREAM CHANNEL RECONNAISSANCE AND
GEOTECHNICAL STABILITY ASSESSMENT
COURTENAY, B.C.**

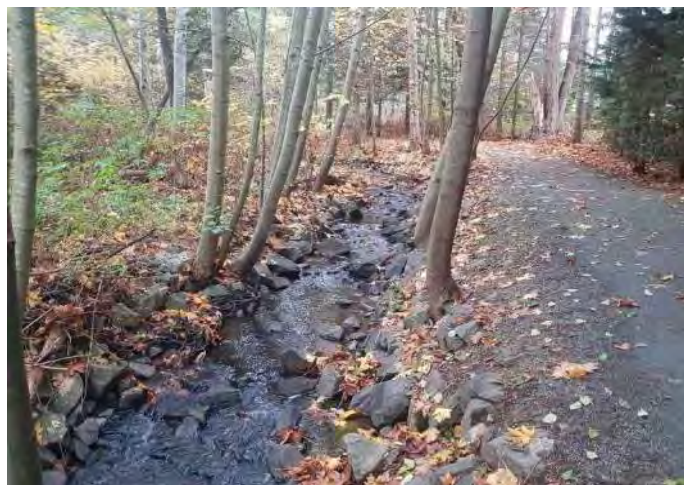
Photo 1, Channel condition downstream of obstruction.

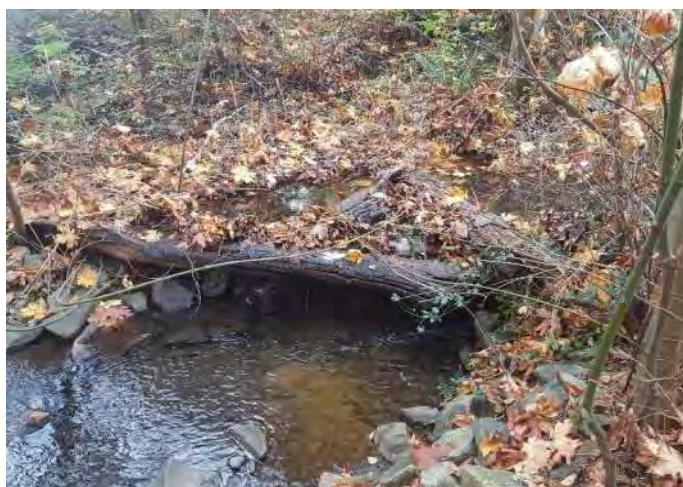
Photo 3, Log jam viewed from downstream.

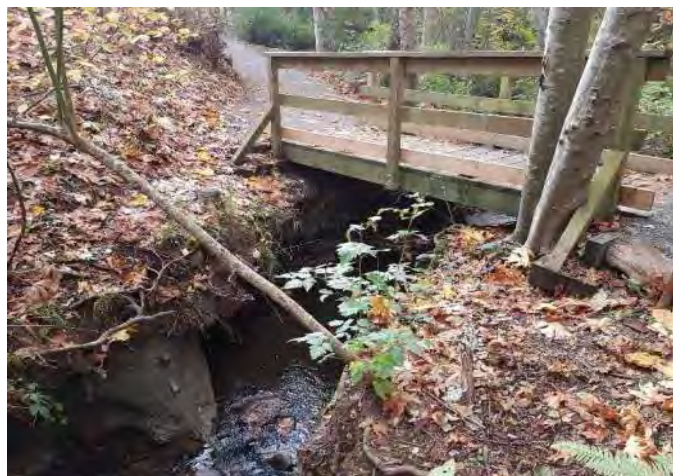
Damage to bridge and pedestrian path if the undermined left abutment collapses.
Could result in injury if someone is on the bridge when collapses.

Soils very dense with slow erosion, may stand despite undermining for several years, high chance of damage to bridge within 20 years. Low likelihood of someone on the bridge during collapse but possible.

Photo 1, Pedestrian bridge and left bank undermining visible.

Repair eroded / undermined banks with riprap or soil bag retaining wall.
Or extend bridge to increase setback between abutments and bank.
Monitor regularly.

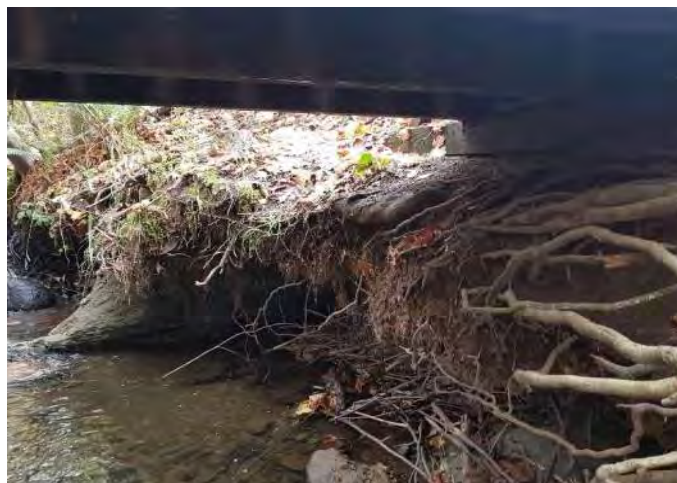
Photo 2, Left bank undermining, bridge abutment visible.

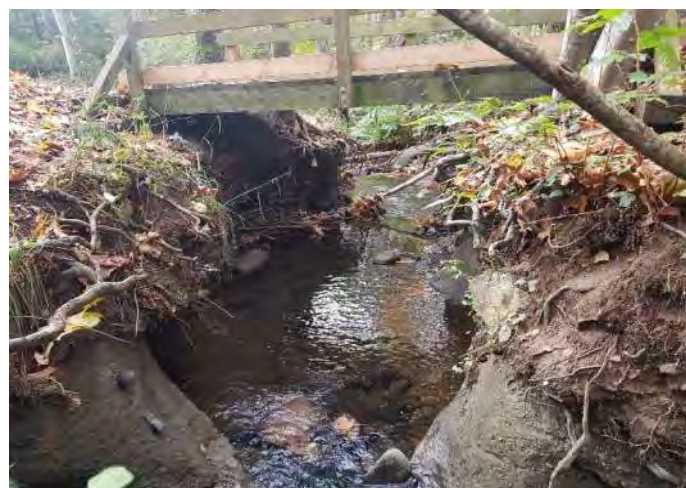
Photo 3, Left and right banks, looking downstream.

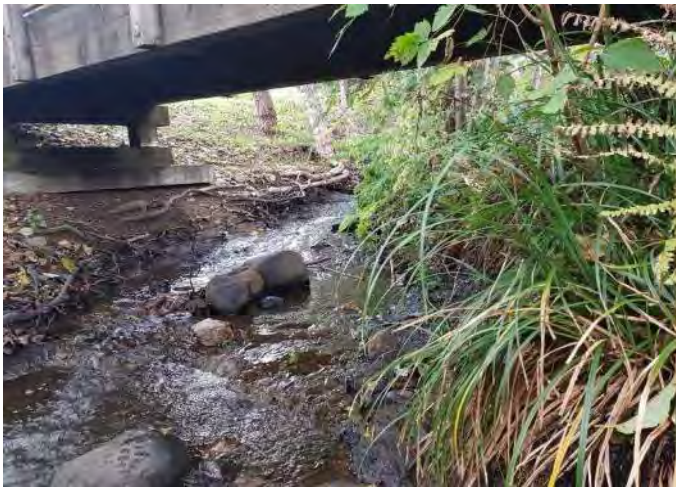
Photo 3, Looking upstream at right bank abutment.

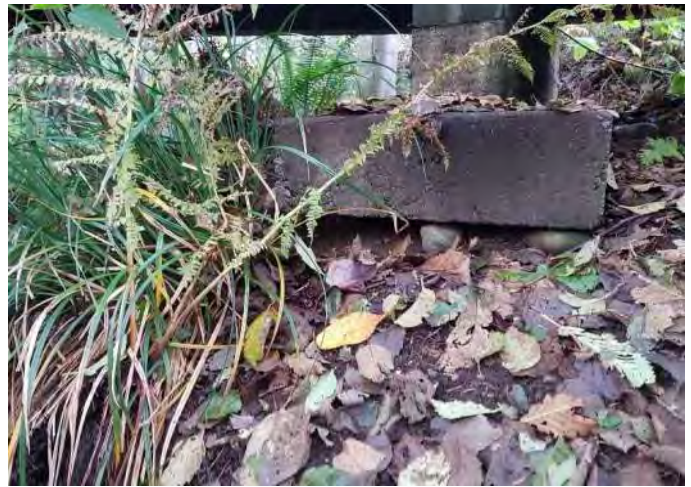
Photo 4, undermining on left bank abutment.
